Access Compliance Report

Public Rights-of-Way

(Curb Ramps)

Intersection ID: 30064	Main Street: CAMPUS_CONNECTION_DR	Cross Street: PAVILION_BV	Location: NE
ADA ID: 46B48CBDF29	Ramp Type: Perp	Initial Pass/Fail: Fail	Overall Compliance: No
Severity Score: 12.5			
Codes/Mitigation Info/Possible Solution		Field Measurements/Component Compliance

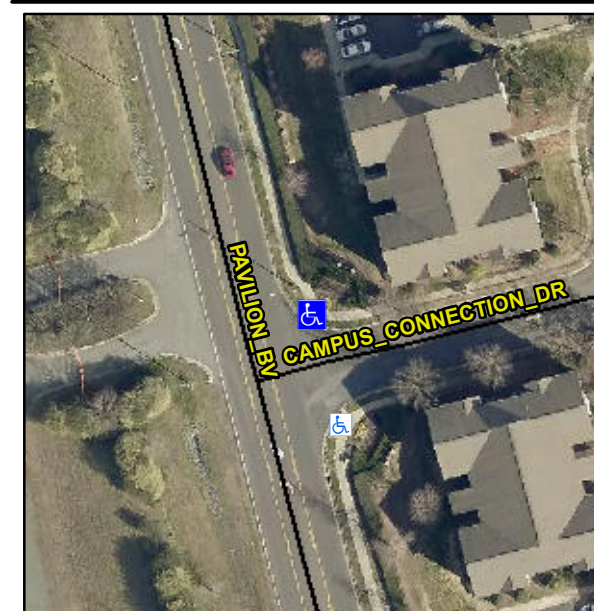
R304.2.2

Compliance	Description	Data	Compliance	Description	Data
N/A	Ramp Length (in)	53.0	No	Ramp Slope (%)	10.8
Yes	Ramp Width (in)	55.0	Yes	Ramp XSlope (%)	1.1
N/A	Flare Type LT	N/A	N/A	Flare Type RT	N/A
N/A	Flare Slope LT (%)	N/A	N/A	Flare Slope RT (%)	N/A
N/A	Flare Traversable LT?	N/A	N/A	Flare Traversable RT?	N/A
N/A	Landing Length (in)	N/A	N/A	DWS Provided?	N/A
N/A	Landing Width (in)	N/A	N/A	DWS Contrast?	N/A
N/A	Landing Slope (%)	N/A	N/A	DWS Length (in)	N/A
N/A	Landing X Slope (%)	N/A	N/A	DWS Full Width?	N/A
N/A	Landing Curb? (Y/N)	N/A	N/A	DWS Offset (in)	N/A
N/A	Shared Landing?	N/A			
N/A	Gutter Ponding?	N/A	N/A	Gutter Slope (%)	N/A
N/A	Gutter Lip Ht (in)	N/A	N/A	Gutter X Slope (%)	N/A
N/A	Painted X Walk1?	No	N/A	Painted X Walk2?	N/A
	X Walk 1 Direction	To S		X Walk 2 Direction	N/A
N/A	X Walk 1 Width (in)	N/A	N/A	X Walk 2 Width (in)	N/A
	X Walk 1 Slope (%)	3.9		X Walk 2 Slope (%)	N/A
	X Walk 1 X Slope (%)	0.4		X Walk 2 X Slope (%)	N/A

Possible Solutions:

Remove & Replace Entire Ramp.
