Access Compliance Report Public Rights-of-Way (Curb Ramps)

Intersection ID: 30280 Main Street: CHALLENGER DR **Cross Street: JUPITER LN** Location: NW **ADA ID: 46B92F96FFC4** Ramp Type: BlendTrans1 Initial Pass/Fail: Pass **Overall Compliance: No Severity Score:**

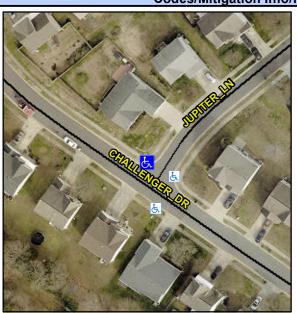
Field Measurements/Component Compliance						
	Compliance Description		Data	Compliance Description		Data
	N/A	Ramp Length (in)	46.0	Yes	BlendTrans Slope (%)	4.0
	Yes	Ramp Width (in)	53.0	Yes	BlendTrans XSlope (%)	0.2
	N/A	Flare Type LT	Sloped	N/A	Flare Type RT	Sloped
	N/A	Flare Slope LT (%)	7.7	N/A	Flare Slope RT (%)	3.9
	N/A	Flare Traversable LT?	No	N/A	Flare Traversable RT?	No
	Yes	Landing Length (in)	48.0	Yes	DWS Provided?	Yes
	Yes	Landing Width (in)	58.5	Yes	DWS Contrast?	Yes
	No	Landing Slope (%)	4.0	Yes	DWS Length (in)	25.5
	Yes	Landing X Slope (%)	0.3	Yes	DWS Full Width?	Yes
	N/A	Landing Curb? (Y/N)	No	No	DWS Offset (in)	3.5
	N/A	Shared Landing?	No			
	No	Gutter Ponding?	Yes	Yes	Gutter Slope (%)	4.5
	Yes	Gutter Lip Ht (in)	0.0	Yes	Gutter X Slope (%)	0.5
	N/A	Painted X Walk1?	No	N/A	Painted X Walk2?	No
		X Walk 1 Direction	To SW		X Walk 2 Direction	To SE
		X Walk 1 Width (in)	N/A		X Walk 2 Width (in)	N/A

X Walk 1 Slope (%)	4.1		X Walk 2 Slope (%)	3.5
		X Walk 1 X Slope (%)	0.3		X Walk 2 X Slope (%)	3.3
	N/A	Ramp inside XWalk1?	N/A	N/A	Ramp inside XWalk2?	N/A
		Road Slope (%)	0.8		Clear Space?	Yes
		Road X Slope (%)	5.9	N/A	Clear Space to XWalk (in)	N/A
	Yes	Any Obstructions?	No	Yes	Storm Grate/Utility Hazard?	No
		Obstruction Type			Storm Grate/Utility Type

Possible Solutions: Remove & Replace Curb Ramp With **Two New Directional Ramps or** Equivalent. Surveyor Notes: N/A PROW/ADA: Not Found, R304.2.2-Perp, R304.3.2-Para, R305.2, R302.7
