## **Access Compliance Report Public Rights-of-Way** (Curb Ramps)

Intersection ID: 10036601 Main Street: RUSHMORE DR Cross Street: N/A Location: ADA ID: 46BB51206A95 Ramp Type: Perp Initial Pass/Fail: Pass **Overall Compliance: No** Severity Score: 15.25

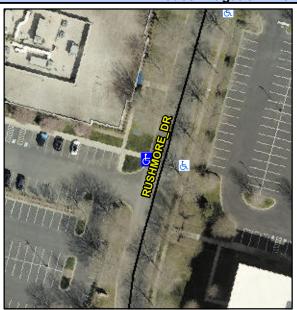
Field Measurements/Component Compliance								
Comp	Compliance Description		Compliance		Description	Data		
N/A	Ramp Length (in)	64.0	Yes	Ram	Slope (%)	5.2		
Yes	Ramp Width (in)	60.0	No	Ramp XSlope (%)		3.3		
N/A	Flare Type LT	Sloped	N/A	Flare Type RT		N/A		
N/A	Flare Slope LT (%)	9.5	N/A	Flare Slope RT (%)		18.5		
N/A	Flare Traversable LT?	No	N/A	Flare Traversable RT?		No		
Yes	Landing Length (in)	51.0	No	DWS	Provided?	No		
Yes	Landing Width (in)	60.0	N/A	DWS	Contrast?	No		
No	Landing Slope (%)	4.2	N/A	DWS	Length (in)	N/A		
No	Landing X Slope (%)	2.7	N/A	DWS	Full Width?	No		
N/A	Landing Curb? (Y/N)	No	N/A	DWS	Offset (in)	N/A		
N/A	Shared Landing?	No						
Yes	Gutter Ponding?	No	No	Gutte	er Slope (%)	7.0		
Yes	Gutter Lip Ht (in)	0.0	No	Gutte	r X Slope (%)	3.2		
N/A	Painted X Walk1?	Yes	N/A	Paint	ed X Walk2?	N/A		
	X Walk 1 Direction	То Е		X Wa	lk 2 Direction	N/A		
N/A	X Walk 1 Width (in)	88.0	N/A	X Wa	lk 2 Width (in)	N/A

X Walk 1 Slope (%)	4.4		X Wa	lk 2 Slope (%)	N/A		
	X Walk 1 X Slope (%)	1.8		X Wa	lk 2 X Slope (%)	N/A		
Yes	Ramp inside XWalk1?	Yes	N/A	Ram	inside XWalk2?	N/A		
	Road Slope (%)	N/A	N/A	Clear	Space?	Yes		
	Road X Slope (%)	N/A	N/A	Clear	Space to XWalk (in)	N/A		
Yes	Any Obstructions?	No	Yes	Storn	n Grate/Utility Hazard?	No		
	Obstruction Type			Storn	n Grate/Utility Type			
		N/A				N/A		
			Yes	Surfa	ce Condition? (G/P)	Good

Possible Solutions: Remove & Replace Entire Ramp. Remove & Replace Gutter. Surveyor Notes: N/A PROW/ADA: Not Found, R304.5.3, R304.2.2-Perp, R304.3.2-Para, R305, R304.5.4
