Access Compliance Report

Public Rights-of-Way (Curb Ramps)

Intersection ID: 3109	Main Street: ASHBURTON_DR	Cross Street: WALDEN_RIDGE_DR	Location: W
ADA ID: 46BF8F92F0AD	Ramp Type: Perp	Initial Pass/Fail: Fail	Overall Compliance: No
Severity Score: 22.5			
Codes/Mitigation Info/Possible Solution		Field Measurements/Component Compliance

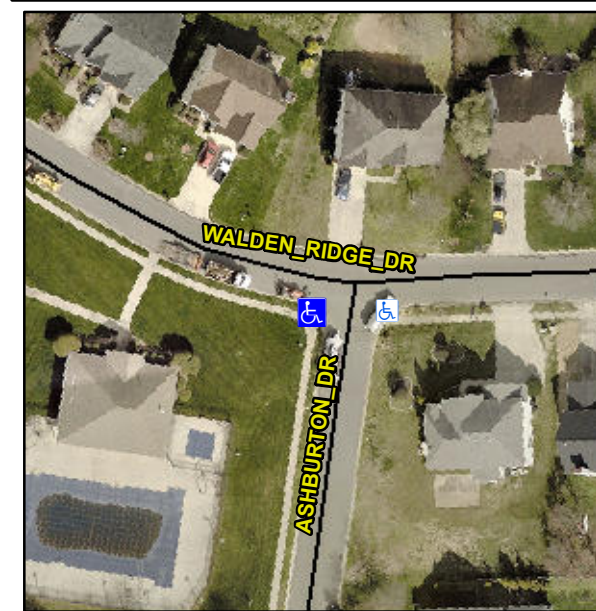
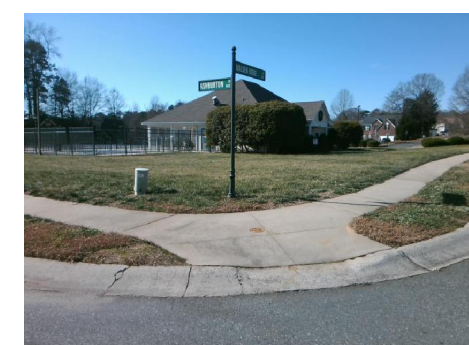
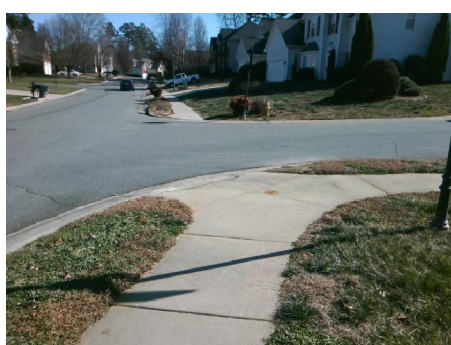
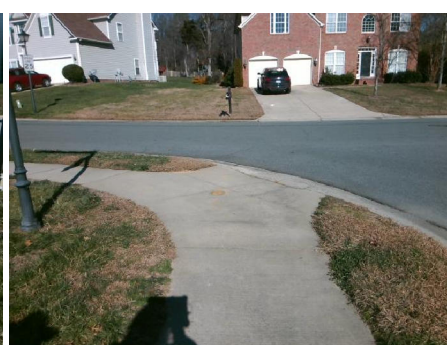
R304.5.1, R304.2.2, R304.5.3

Compliance	Description	Data	Compliance	Description	Data
N/A	Ramp Length (in)	40.0	No	Ramp Slope (%)	11.7
No	Ramp Width (in)	38.0	No	Ramp XSlope (%)	3.5
N/A	Flare Type LT	N/A	N/A	Flare Type RT	N/A
N/A	Flare Slope LT (%)	N/A	N/A	Flare Slope RT (%)	N/A
N/A	Flare Traversable LT?	N/A	N/A	Flare Traversable RT?	N/A
N/A	Landing Length (in)	N/A	N/A	DWS Provided?	N/A
N/A	Landing Width (in)	N/A	N/A	DWS Contrast?	N/A
N/A	Landing Slope (%)	N/A	N/A	DWS Length (in)	N/A
N/A	Landing X Slope (%)	N/A	N/A	DWS Full Width?	N/A
N/A	Landing Curb? (Y/N)	N/A	N/A	DWS Offset (in)	N/A
N/A	Shared Landing?	N/A			
N/A	Gutter Ponding?	N/A	N/A	Gutter Slope (%)	N/A
N/A	Gutter Lip Ht (in)	N/A	N/A	Gutter X Slope (%)	N/A
N/A	Painted X Walk1?	No	N/A	Painted X Walk2?	N/A
	X Walk 1 Direction	To E		X Walk 2 Direction	N/A
N/A	X Walk 1 Width (in)	N/A	N/A	X Walk 2 Width (in)	N/A
	X Walk 1 Slope (%)	0.3		X Walk 2 Slope (%)	N/A
	X Walk 1 X Slope (%)	0.7		X Walk 2 X Slope (%)	N/A

N/A	Ramp inside XWalk1?	N/A	N/A	Ramp inside XWalk2?	N/A
	Road Slope (%)	N/A	N/A	Clear Space?	N/A
	Road X Slope (%)	N/A	N/A	Clear Space to XWalk (in)	N/A
N/A	Any Obstructions?	N/A	N/A	Storm Grate/Utility Hazard?	N/A
	Obstruction Type			Storm Grate/Utility Type	
		N/A			N/A
		Yes		Surface Condition? (G/P)	Good

Possible Solutions:

Remove & Replace Entire Ramp.

Total Cost: \$ 1850.00
