# Access Compliance Report

## Public Rights-of-Way

### (Curb Ramps)

Intersection ID: 15694	Main Street: MAYVIEW_DR	Cross Street: MONROE_RD	Location:	N
ADA ID: 46C3D70C4C94	Ramp Type: BlendTrans2	Initial Pass/Fail: Fail	Overall Compliance: No	Severity Score: 8.75
Codes/Mitigation Info/Possible Solution		Field Measurements/Component Compliance

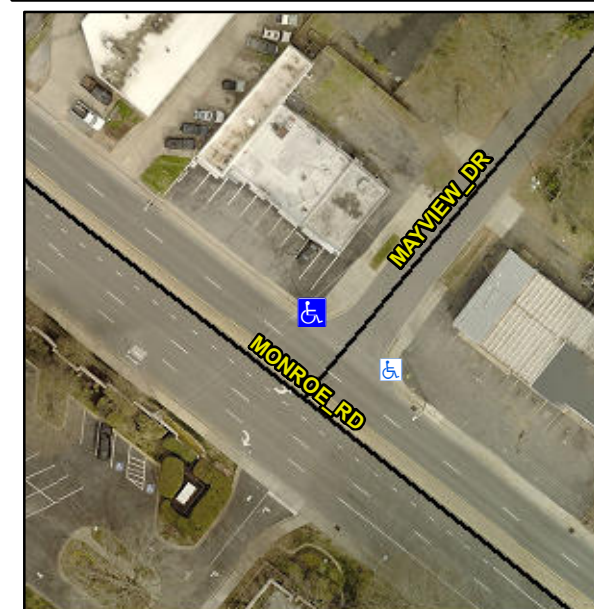
**Not Found, R304.5.1**

Compliance	Description	Data	Compliance	Description	Data
N/A	Ramp Length (in)	70.0	Yes	BlendTrans Slope (%)	4.3
No	Ramp Width (in)	40.0	Yes	BlendTrans XSlope (%)	0.7
N/A	Flare Type LT	N/A	N/A	Flare Type RT	N/A
N/A	Flare Slope LT (%)	N/A	N/A	Flare Slope RT (%)	N/A
N/A	Flare Traversable LT?	N/A	N/A	Flare Traversable RT?	N/A
N/A	Landing Length (in)	N/A	N/A	DWS Provided?	N/A
N/A	Landing Width (in)	N/A	N/A	DWS Contrast?	N/A
N/A	Landing Slope (%)	N/A	N/A	DWS Length (in)	N/A
N/A	Landing X Slope (%)	N/A	N/A	DWS Full Width?	N/A
N/A	Landing Curb? (Y/N)	N/A	N/A	DWS Offset (in)	N/A
N/A	Shared Landing?	N/A			
N/A	Gutter Ponding?	N/A	N/A	Gutter Slope (%)	N/A
N/A	Gutter Lip Ht (in)	N/A	N/A	Gutter X Slope (%)	N/A
N/A	Painted X Walk1?	No	N/A	Painted X Walk2?	N/A
	X Walk 1 Direction	To SE		X Walk 2 Direction	N/A
	X Walk 1 Width (in)	N/A		X Walk 2 Width (in)	N/A
	X Walk 1 Slope (%)	1.8		X Walk 2 Slope (%)	N/A
	X Walk 1 X Slope (%)	1.5		X Walk 2 X Slope (%)	N/A

N/A	Ramp inside XWalk1?	N/A	N/A	Ramp inside XWalk2?	N/A
	Road Slope (%)	1.5		Clear Space?	N/A
	Road X Slope (%)	1.8	N/A	Clear Space to XWalk (in)	N/A
N/A	Any Obstructions?	N/A	N/A	Storm Grate/Utility Hazard?	N/A
	Obstruction Type			Storm Grate/Utility Type	
		N/A			N/A
			Yes	Surface Condition? (G/P)	Good
			No	Curb Slope (%)	15.8

**Remove & Replace Curb Ramp With Two New Directional Ramps or Equivalent.**

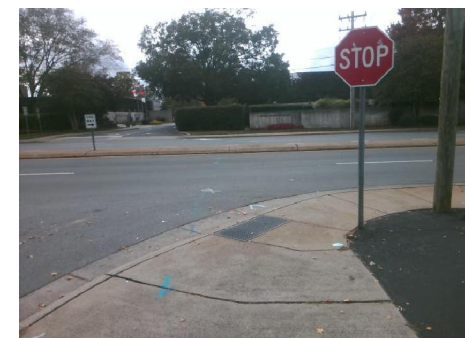
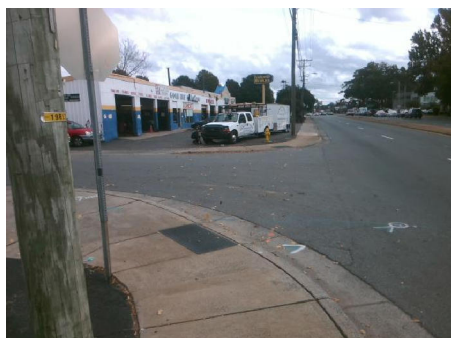
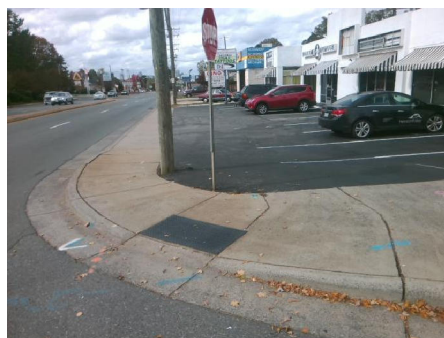
Street 1 Name	MAYVIEW DR
Stop Condition-Street 1	StopSign
Street 2 Name	N/A
Stop Condition-Street 2	N/A
