# Access Compliance Report

## Public Rights-of-Way

### (Curb Ramps)

Intersection ID: 12320	Main Street: ALLEN_ST	Cross Street: BELMONT_AV	Location: W
ADA ID: 46C468016912	Ramp Type: PerpDiag	Initial Pass/Fail: Fail	Overall Compliance: No
Severity Score: 8.75			
Codes/Mitigation Info/Possible Solution		Field Measurements/Component Compliance

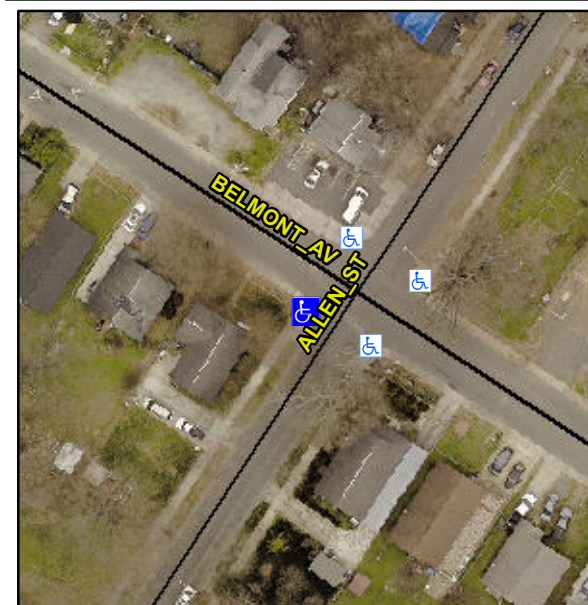
**Not Found, R304.5.1**

Compliance	Description	Data	Compliance	Description	Data
N/A	Ramp Length (in)	66.5	Yes	Ramp Slope (%)	6.0
No	Ramp Width (in)	47.0	Yes	Ramp XSlope (%)	0.4
N/A	Flare Type LT	N/A	N/A	Flare Type RT	N/A
N/A	Flare Slope LT (%)	N/A	N/A	Flare Slope RT (%)	N/A
N/A	Flare Traversable LT?	N/A	N/A	Flare Traversable RT?	N/A
N/A	Landing Length (in)	N/A	N/A	DWS Provided?	N/A
N/A	Landing Width (in)	N/A	N/A	DWS Contrast?	N/A
N/A	Landing Slope (%)	N/A	N/A	DWS Length (in)	N/A
N/A	Landing X Slope (%)	N/A	N/A	DWS Full Width?	N/A
N/A	Landing Curb? (Y/N)	N/A	N/A	DWS Offset (in)	N/A
N/A	Shared Landing?	N/A			
N/A	Gutter Ponding?	N/A	N/A	Gutter Slope (%)	N/A
N/A	Gutter Lip Ht (in)	0.5	N/A	Gutter X Slope (%)	N/A
N/A	Painted X Walk1?	No	N/A	Painted X Walk2?	No
	X Walk 1 Direction	To SE		X Walk 2 Direction	To NE
N/A	X Walk 1 Width (in)	N/A	N/A	X Walk 2 Width (in)	N/A
	X Walk 1 Slope (%)	2.1		X Walk 2 Slope (%)	2.4
	X Walk 1 X Slope (%)	1.2		X Walk 2 X Slope (%)	2.4

N/A	Ramp inside XWalk1?	N/A	N/A	Ramp inside XWalk2?	N/A
	Road Slope (%)	0.7	N/A	Clear Space?	N/A
	Road X Slope (%)	3.4	N/A	Clear Space to XWalk (in)	N/A
N/A	Any Obstructions?	N/A	N/A	Storm Grate/Utility Hazard?	N/A
	Obstruction Type			Storm Grate/Utility Type	
		N/A			N/A
			Yes	Surface Condition? (G/P)	Good

**Remove & Replace Curb Ramp With Two New Directional Ramps or Equivalent.**
