# Access Compliance Report

## Public Rights-of-Way

### (Curb Ramps)

| Intersection ID: 10027726 | Main Street: GRIFFITH_RD | Cross Street: N/A | Location: SE |

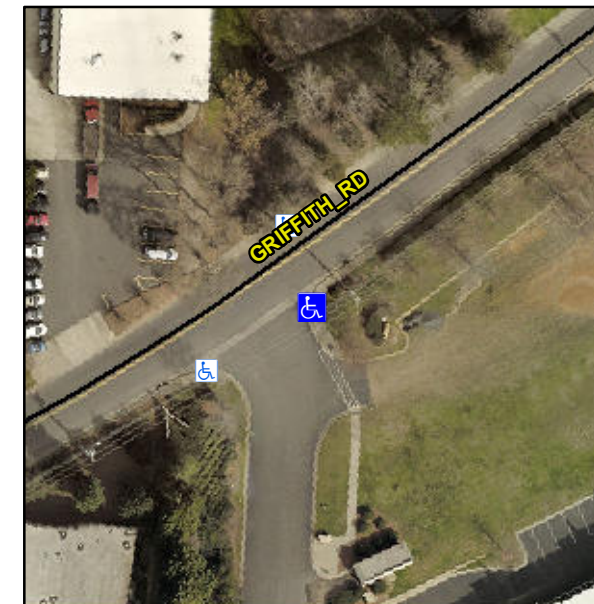
#### Field Measurements/Component Compliance

| ADA ID: 46CAB1CDD8D9 | Ramp Type: PerpDiag | Initial Pass/Fail: Fail | Overall Compliance: No |

| Compliance | Description | Data | Compliance | Description | Data |
|---|---|---|---|---|---|
| N/A | Ramp Length (in) | 31.0 | No | Ramp Slope (%) | 9.6 |
| No | Ramp Width (in) | 47.5 | No | Ramp XSlope (%) | 3.0 |

**Remove & Replace Curb Ramp With Two New Directional Ramps or Equivalent.**

**R304.5.1, R304.2.2, R304.5.3**

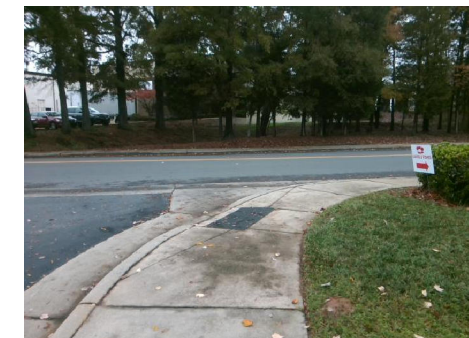
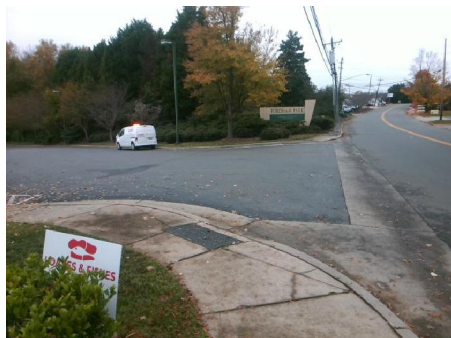
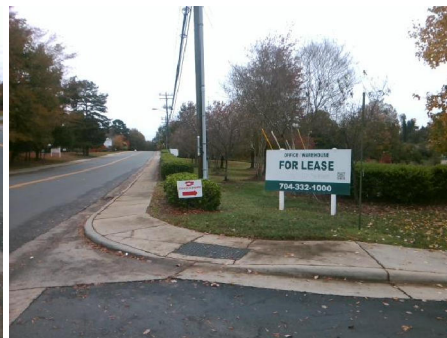
Street 1 Name **GRIFFITH RD**  
 Stop Condition-Street 2 **None**  
 Street 2 Name **ENTRANCE**  
 Stop Condition-Street 1 **StopSign**
