Access Compliance Report

Public Rights-of-Way

(Curb Ramps)

Intersection ID: 29247	Main Street: CASTELLO_LN	Cross Street: MALLARD_FOREST_DR	Location: SE
ADA ID: 46CC9FF5DA25	Ramp Type: BlendTrans1	Initial Pass/Fail: Fail	Overall Compliance: No
Severity Score: 18.75			
Codes/Mitigation Info/Possible Solution		Field Measurements/Component Compliance

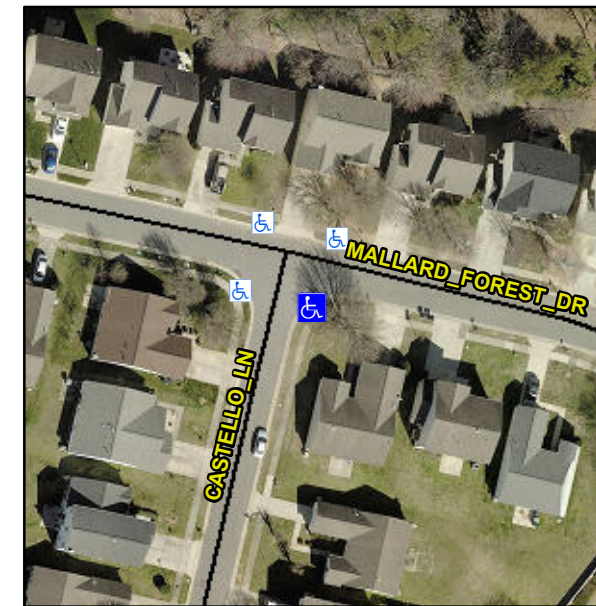
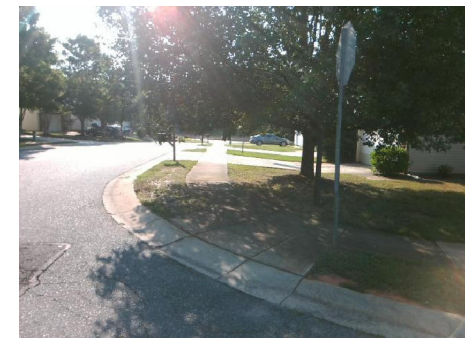
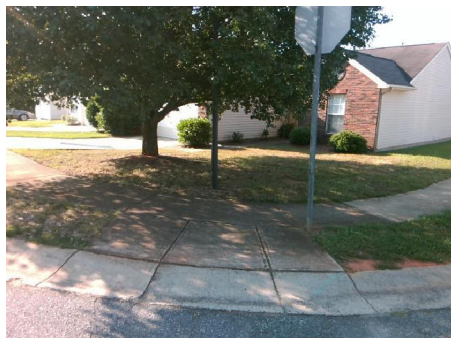
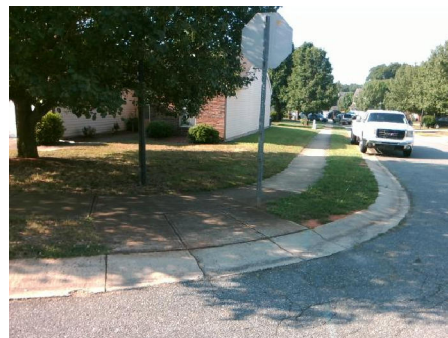
Not Found, R304.5.1, R304.5.3

Compliance	Description	Data	Compliance	Description	Data
N/A	Ramp Length (in)	48.0	Yes	BlendTrans Slope (%)	1.9
No	Ramp Width (in)	34.5	No	BlendTrans XSlope (%)	3.7
N/A	Flare Type LT	N/A	N/A	Flare Type RT	N/A
N/A	Flare Slope LT (%)	N/A	N/A	Flare Slope RT (%)	N/A
N/A	Flare Traversable LT?	N/A	N/A	Flare Traversable RT?	N/A
N/A	Landing Length (in)	N/A	N/A	DWS Provided?	N/A
N/A	Landing Width (in)	N/A	N/A	DWS Contrast?	N/A
N/A	Landing Slope (%)	N/A	N/A	DWS Length (in)	N/A
N/A	Landing X Slope (%)	N/A	N/A	DWS Full Width?	N/A
N/A	Landing Curb? (Y/N)	N/A	N/A	DWS Offset (in)	N/A
N/A	Shared Landing?	N/A			
N/A	Gutter Ponding?	N/A	N/A	Gutter Slope (%)	N/A
N/A	Gutter Lip Ht (in)	0.5	N/A	Gutter X Slope (%)	N/A
N/A	Painted X Walk1?	No	N/A	Painted X Walk2?	No
	X Walk 1 Direction	To N		X Walk 2 Direction	To W
	X Walk 1 Width (in)	N/A		X Walk 2 Width (in)	N/A
	X Walk 1 Slope (%)	4.3		X Walk 2 Slope (%)	4.7
	X Walk 1 X Slope (%)	0.0		X Walk 2 X Slope (%)	4.9

N/A	Ramp inside XWalk1?	N/A	N/A	Ramp inside XWalk2?	N/A
	Road Slope (%)	5.2		Clear Space?	N/A
	Road X Slope (%)	4.7	N/A	Clear Space to XWalk (in)	N/A
N/A	Any Obstructions?	N/A	N/A	Storm Grate/Utility Hazard?	N/A
	Obstruction Type			Storm Grate/Utility Type	
		N/A			N/A
			Yes	Surface Condition? (G/P)	Good
			No	Curb Slope (%)	14.3

Remove & Replace Curb Ramp With Two New Directional Ramps or Equivalent.
