Access Compliance Report

Public Rights-of-Way

(Curb Ramps)

Intersection ID: 9841	Main Street: N_GRAHAM_ST	Cross Street: WOODWARD_AV	Location: N
ADA ID: 46CDE32F8160	Ramp Type: ParaDiag	Initial Pass/Fail: Pass	Overall Compliance: No
Severity Score: 0.25			
Codes/Mitigation Info/Possible Solution		Field Measurements/Component Compliance

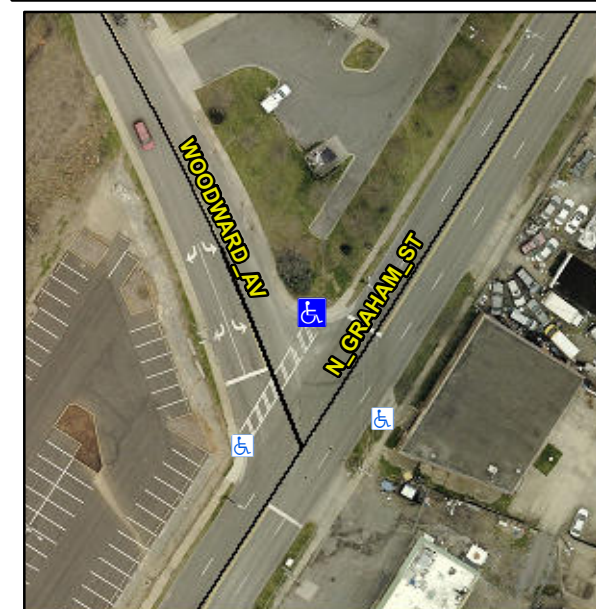
Compliance	Description	Data	Compliance	Description	Data
N/A	Ramp Length LT (in)	57.0	N/A	Ramp Length RT (in)	47.5
Yes	Ramp Width LT (in)	66.5	Yes	Ramp Width RT (in)	64.5
Yes	Ramp Slope LT (%)	7.9	Yes	Ramp Slope RT (%)	5.7
No	Ramp XSlope LT (%)	2.1	Yes	Ramp XSlope RT (%)	1.0
Yes	Landing Length (in)	66.0	Yes	DWS Provided?	Yes
No	Landing Width (in)	44.0	Yes	DWS Contrast?	Yes
Yes	Landing Slope (%)	1.9	Yes	DWS Length (in)	24.0
Yes	Landing X Slope (%)	1.6	Yes	DWS Full Width?	Yes
N/A	Landing Curb? (Y/N)	No	Yes	DWS Offset (in)	1.0
N/A	Shared Landing?	No			
Yes	Gutter Ponding?	No	Yes	Gutter Slope (%)	4.5
Yes	Gutter Lip Ht (in)	0.0	Yes	Gutter X Slope (%)	0.5
N/A	Painted X Walk1?	Yes	N/A	Painted X Walk2?	No
	X Walk 1 Direction	To SW		X Walk 2 Direction	To SE
N/A	X Walk 1 Width (in)	85.0	N/A	X Walk 2 Width (in)	N/A
	X Walk 1 Slope (%)	1.2		X Walk 2 Slope (%)	2.9
	X Walk 1 X Slope (%)	1.6		X Walk 2 X Slope (%)	2.4
Yes	Ramp inside XWalk1?	Yes	N/A	Ramp inside XWalk2?	N/A

Road Slope (%)	0.8	N/A	Clear Space?	Yes
	Road X Slope (%)	0.2	N/A	Clear Space to XWalk (in)	N/A
Yes	Any Obstructions?	No	Yes	Storm Grate/Utility Hazard?	No
	Obstruction Type			Storm Grate/Utility Type	
		N/A			N/A
			Yes	Surface Condition? (G/P)	Good
			N/A	Curb Slope (%)	2.2

Possible Solutions:

Remove & Replace Curb Ramp With Two New Directional Ramps or Equivalent.
