Access Compliance Report

Public Rights-of-Way

(Curb Ramps)

Intersection ID: 47839	Main Street: PECO_RD	Cross Street: ALVARADO_WY	Location: SW
ADA ID: 46F120170C93	Ramp Type: PerpDiag	Initial Pass/Fail: Fail	Overall Compliance: No
		Severity Score: 10

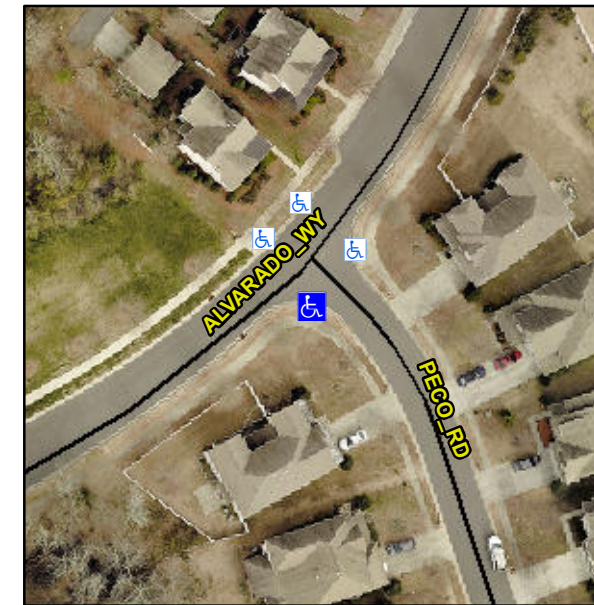
Compliance	Description	Data	Compliance	Description	Data
N/A	Ramp Length (in)	133.0	Yes	Ramp Slope (%)	5.4
No	Ramp Width (in)	46.5	No	Ramp XSlope (%)	2.9
N/A	Flare Type LT	N/A	N/A	Flare Type RT	N/A
N/A	Flare Slope LT (%)	N/A	N/A	Flare Slope RT (%)	N/A
N/A	Flare Traversable LT?	N/A	N/A	Flare Traversable RT?	N/A
N/A	Landing Length (in)	N/A	N/A	DWS Provided?	N/A
N/A	Landing Width (in)	N/A	N/A	DWS Contrast?	N/A
N/A	Landing Slope (%)	N/A	N/A	DWS Length (in)	N/A
N/A	Landing X Slope (%)	N/A	N/A	DWS Full Width?	N/A
N/A	Landing Curb? (Y/N)	N/A	N/A	DWS Offset (in)	N/A
N/A	Shared Landing?	N/A			
N/A	Gutter Ponding?	N/A	N/A	Gutter Slope (%)	N/A
N/A	Gutter Lip Ht (in)	N/A	N/A	Gutter X Slope (%)	N/A
N/A	Painted X Walk1?	No	N/A	Painted X Walk2?	No
	X Walk 1 Direction	To NE		X Walk 2 Direction	To NW
N/A	X Walk 1 Width (in)	N/A	N/A	X Walk 2 Width (in)	N/A
	X Walk 1 Slope (%)	1.2		X Walk 2 Slope (%)	0.6
	X Walk 1 X Slope (%)	0.9		X Walk 2 X Slope (%)	1.6

N/A	Ramp inside XWalk1?	N/A	N/A	Ramp inside XWalk2?	N/A
	Road Slope (%)	1.3	N/A	Clear Space?	N/A
	Road X Slope (%)	2.2	N/A	Clear Space to XWalk (in)	N/A
N/A	Any Obstructions?	N/A	N/A	Storm Grate/Utility Hazard?	N/A
	Obstruction Type			Storm Grate/Utility Type	
		N/A			N/A
			Yes	Surface Condition? (G/P)	Good

Remove & Replace Curb Ramp With Two New Directional Ramps or Equivalent.

R304.5.1, R304.5.3
