Access Compliance Report

Public Rights-of-Way

(Curb Ramps)

Intersection ID: 53886	Main Street: PAW_VALLEY_LN	Cross Street: PAW_VILLAGE_RD	Location: E
ADA ID: 46F48559FE60	Ramp Type: Perp	Initial Pass/Fail: Fail	Overall Compliance: No
Codes/Mitigation Info/Possible Solution		Field Measurements/Component Compliance	
Severity Score: 8.75

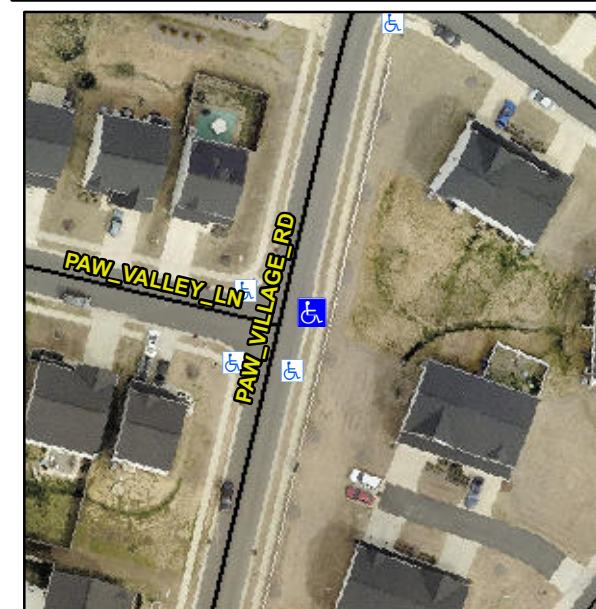
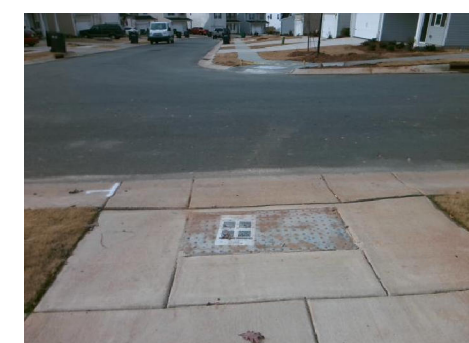
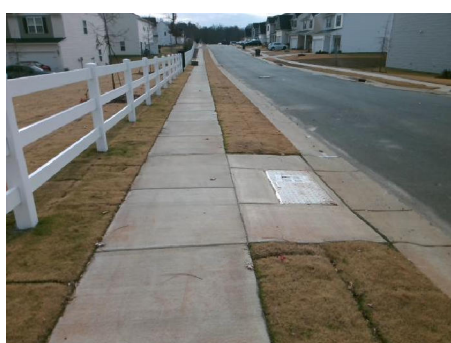
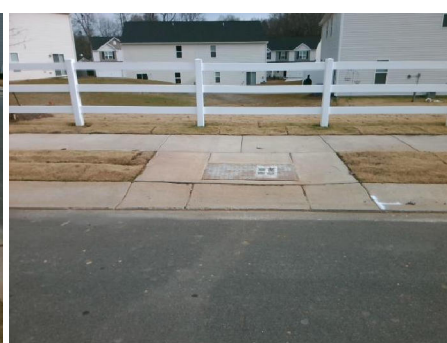
Not Found, R304.5.1

Compliance	Description	Data	Compliance	Description	Data
N/A	Ramp Length (in)	47.0	Yes	Ramp Slope (%)	7.7
No	Ramp Width (in)	47.0	Yes	Ramp XSlope (%)	1.8
N/A	Flare Type LT	N/A	N/A	Flare Type RT	N/A
N/A	Flare Slope LT (%)	N/A	N/A	Flare Slope RT (%)	N/A
N/A	Flare Traversable LT?	N/A	N/A	Flare Traversable RT?	N/A
N/A	Landing Length (in)	N/A	N/A	DWS Provided?	N/A
N/A	Landing Width (in)	N/A	N/A	DWS Contrast?	N/A
N/A	Landing Slope (%)	N/A	N/A	DWS Length (in)	N/A
N/A	Landing X Slope (%)	N/A	N/A	DWS Full Width?	N/A
N/A	Landing Curb? (Y/N)	N/A	N/A	DWS Offset (in)	N/A
N/A	Shared Landing?	N/A			
N/A	Gutter Ponding?	N/A	N/A	Gutter Slope (%)	N/A
N/A	Gutter Lip Ht (in)	N/A	N/A	Gutter X Slope (%)	N/A
N/A	Painted X Walk1?	No	N/A	Painted X Walk2?	N/A
	X Walk 1 Direction	To NW		X Walk 2 Direction	N/A
N/A	X Walk 1 Width (in)	N/A	N/A	X Walk 2 Width (in)	N/A
	X Walk 1 Slope (%)	4.2		X Walk 2 Slope (%)	N/A
	X Walk 1 X Slope (%)	1.9		X Walk 2 X Slope (%)	N/A

N/A	Ramp inside XWalk1?	N/A	N/A	Ramp inside XWalk2?	N/A
	Road Slope (%)	N/A	N/A	Clear Space?	N/A
	Road X Slope (%)	N/A	N/A	Clear Space to XWalk (in)	N/A
N/A	Any Obstructions?	N/A	N/A	Storm Grate/Utility Hazard?	N/A
	Obstruction Type			Storm Grate/Utility Type	
		N/A			N/A
			Yes	Surface Condition? (G/P)	Good

Possible Solutions:

Remove & Replace Entire Ramp.

Total Cost: \$ 1850.00
