Access Compliance Report Public Rights-of-Way (Curb Ramps)

Intersection ID: 8879 Main Street: LAMBETH_DR Cross Street: N_TRYON_ST Location: NW

ADA ID: 46F85ED1CAD7 Ramp Type: ParaDiag Initial Pass/Fail: Fail Overall Compliance: No Severity Score: 13.75

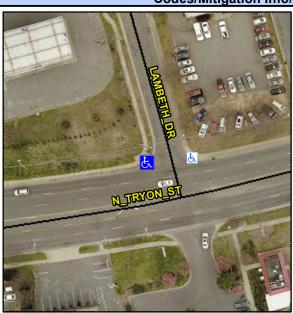
LT RP < 5%

Comp	liance Description	liance Description	Data		
N/A	Ramp Length LT (in)	5.0	N/A	Ramp Length RT (in)	51.0
Yes	Ramp Width LT (in)	55.0	Yes	Ramp Width RT (in)	59.0
Yes	Ramp Slope LT (%)	3.3	No	Ramp Slope RT (%)	11.3
Yes	Ramp XSlope LT (%)	1.0	No	Ramp XSlope RT (%)	3.0
N/A	Landing Length (in)	N/A	N/A	DWS Provided?	N/A
N/A	Landing Width (in)	N/A	N/A	DWS Contrast?	N/A
N/A	Landing Slope (%)	N/A	N/A	DWS Length (in)	N/A
N/A	Landing X Slope (%)	N/A	N/A	DWS Full Width?	N/A
N/A	Landing Curb? (Y/N)	N/A	N/A	DWS Offset (in)	N/A
N/A	Shared Landing?	N/A			
N/A	Gutter Ponding?	N/A	N/A	Gutter Slope (%)	N/A
N/A	Gutter Lip Ht (in)	N/A	N/A	Gutter X Slope (%)	N/A
N/A	Painted X Walk1?	No	N/A	Painted X Walk2?	No
	X Walk 1 Direction	To S		X Walk 2 Direction	To E
N/A	X Walk 1 Width (in)	N/A	N/A	X Walk 2 Width (in)	N/A
	X Walk 1 Slope (%)	5.0		X Walk 2 Slope (%)	3.3
	X Walk 1 X Slope (%)	2.4		X Walk 2 X Slope (%)	1.2
N/A	Ramp inside XWalk1?	N/A	N/A	Ramp inside XWalk2?	N/A

Road Slope (%)	1.7	N/A	Clear Space?	N/A
	Road X Slope (%)	5.6	N/A	Clear Space to XWalk (in)	N/A
N/A	Any Obstructions?	N/A	N/A	Storm Grate/Utility Hazard?	N/A
	Obstruction Type			Storm Grate/Utility Type	
		N/A			N/A
			Yes	Surface Condition? (G/P)	Good
			N/A	Curb Slope (%)	16.7

Remove & Replace Curb Ramp With
Two New Directional Ramps or
Equivalent.
