Access Compliance Report

Public Rights-of-Way

(Curb Ramps)

Intersection ID: 9911	Main Street: BURTON_ST	Cross Street: OAKLAWN_AV	Location: SE
ADA ID: 46FC9CD754E6	Ramp Type: PerpDiag	Initial Pass/Fail: Fail	Overall Compliance: No
		Severity Score: 25

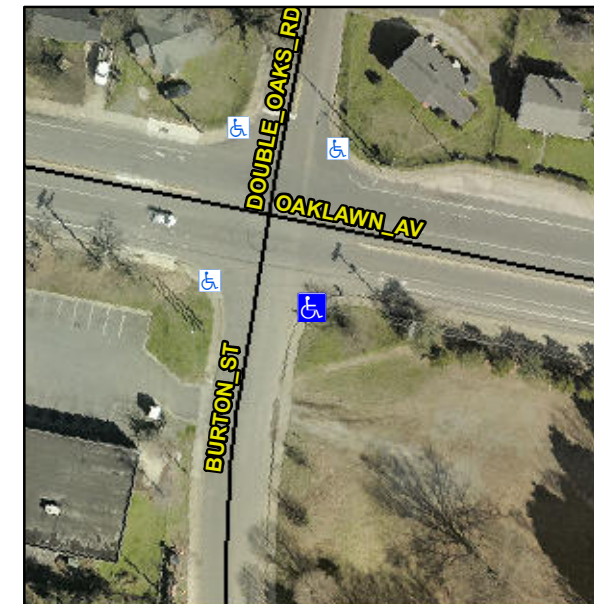
Not Found, R304.2.2, R304.5.3

Compliance	Description	Data	Compliance	Description	Data
N/A	Ramp Length (in)	59.0	No	Ramp Slope (%)	11.9
Yes	Ramp Width (in)	57.0	No	Ramp XSlope (%)	6.1
N/A	Flare Type LT	N/A	N/A	Flare Type RT	N/A
N/A	Flare Slope LT (%)	N/A	N/A	Flare Slope RT (%)	N/A
N/A	Flare Traversable LT?	N/A	N/A	Flare Traversable RT?	N/A
N/A	Landing Length (in)	N/A	N/A	DWS Provided?	N/A
N/A	Landing Width (in)	N/A	N/A	DWS Contrast?	N/A
N/A	Landing Slope (%)	N/A	N/A	DWS Length (in)	N/A
N/A	Landing X Slope (%)	N/A	N/A	DWS Full Width?	N/A
N/A	Landing Curb? (Y/N)	N/A	N/A	DWS Offset (in)	N/A
N/A	Shared Landing?	N/A			
N/A	Gutter Ponding?	N/A	N/A	Gutter Slope (%)	N/A
N/A	Gutter Lip Ht (in)	1.0	N/A	Gutter X Slope (%)	N/A
N/A	Painted X Walk1?	No	N/A	Painted X Walk2?	No
	X Walk 1 Direction	To N		X Walk 2 Direction	To W
N/A	X Walk 1 Width (in)	N/A	N/A	X Walk 2 Width (in)	N/A
	X Walk 1 Slope (%)	3.5		X Walk 2 Slope (%)	2.3
	X Walk 1 X Slope (%)	3.8		X Walk 2 X Slope (%)	3.6

N/A	Ramp inside XWalk1?	N/A	N/A	Ramp inside XWalk2?	N/A
	Road Slope (%)	2.7	N/A	Clear Space?	N/A
	Road X Slope (%)	2.8	N/A	Clear Space to XWalk (in)	N/A
N/A	Any Obstructions?	N/A	N/A	Storm Grate/Utility Hazard?	N/A
	Obstruction Type			Storm Grate/Utility Type	
		N/A			N/A
			Yes	Surface Condition? (G/P)	Good

Remove & Replace Curb Ramp With Two New Directional Ramps or Equivalent.
