# Access Compliance Report

## Public Rights-of-Way

### (Curb Ramps)

| Intersection ID: 11907 | Main Street: PHIFER_AV | Cross Street: N_COLLEGE_ST | Location: N |

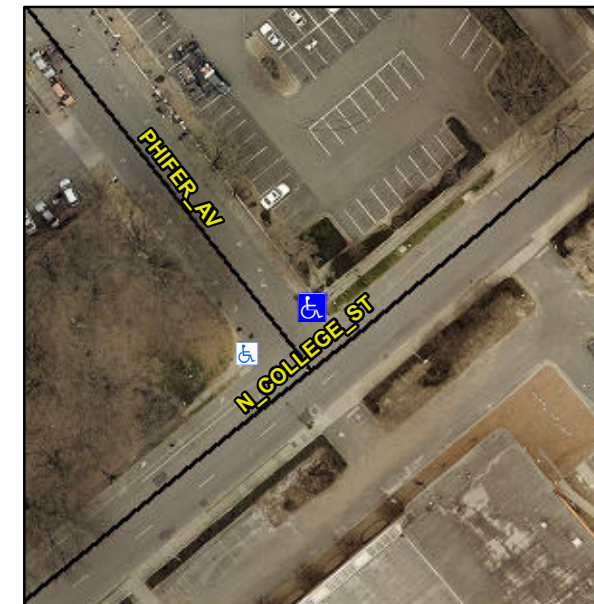
| ADA ID: 47151D2FAE77 | Ramp Type: Directional1 | Initial Pass/Fail: Fail | Overall Compliance: No |
| | | Severity Score: 10 | |

| Compliance | Description | Data | Compliance | Description | Data |
|---|---|---|---|---|---|
| No | Ramp Width (in) | 47.0 | N/A | Grade Break Slope (%) | 0.0 |
| No | Ramp XSlope (%) | 2.8 | | | |

**Remove & Replace Entire Ramp.**

**R304.5.1, R304.5.3**
