# Access Compliance Report

## Public Rights-of-Way

### (Curb Ramps)

| Intersection ID: 49313 | Main Street: ROCKLAND_DR | Cross Street: MISTY_EVE_LN | Location: NE |

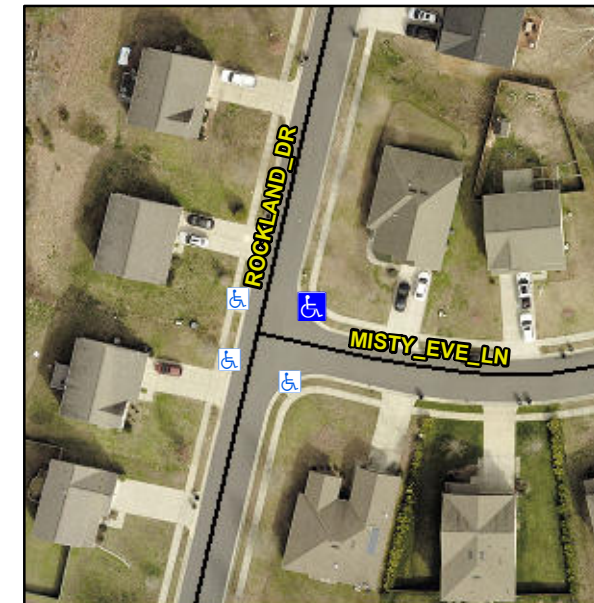
**CURB GAP 1.5**

**Not Found, R304.5.1, R304.5.3**

**Remove & Replace Curb Ramp With Two New Directional Ramps or Equivalent.**

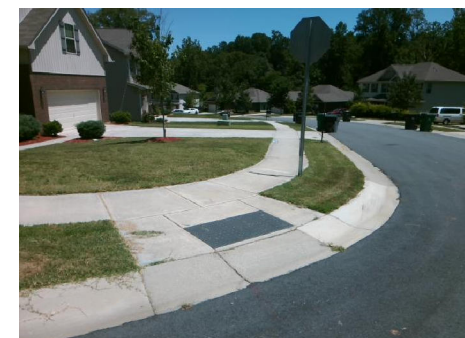
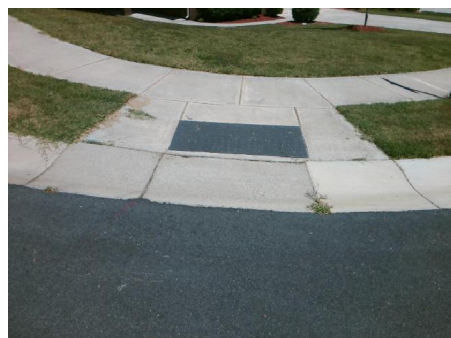
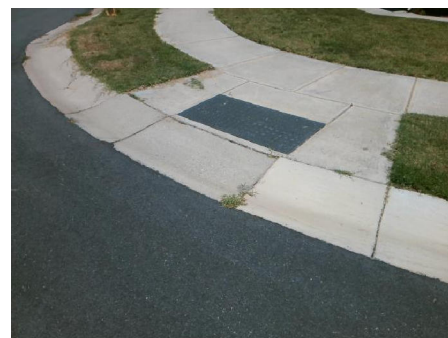
| Compliance | Description | Data | Compliance | Description | Data |
|---|---|---|---|---|---|
| No | Ramp Width (in) | 47.0 | No | BlendTrans XSlope (%) | 3.7 |
