## Access Compliance Report Public Rights-of-Way (Curb Ramps)

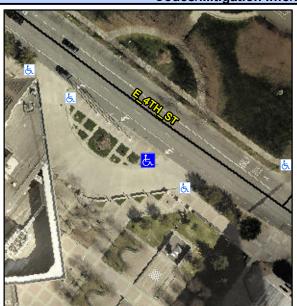
Intersection ID: N/AMain Street: E\_4TH\_STCross Street: N/ALocation:NWADA ID: 4719790571A5Ramp Type: PerpInitial Pass/Fail: FailOverall Compliance: NoSeverity Score: 13.75

Field Measurements/Component Compliance								
Comp	Compliance Description		Comp	liance Description	Data			
N/A	Ramp Length (in)	85.0	No	Ramp Slope (%)	8.8			
Yes	Ramp Width (in)	73.0	No	Ramp XSlope (%)	2.3			
N/A	Flare Type LT	N/A	N/A	Flare Type RT	N/A			
N/A	Flare Slope LT (%)	N/A	N/A	Flare Slope RT (%)	N/A			
N/A	Flare Traversable LT?	No	N/A	Flare Traversable RT?	No			
N/A	Landing Length (in)	N/A	N/A	DWS Provided?	N/A			
N/A	Landing Width (in)	N/A	N/A	DWS Contrast?	N/A			
N/A	Landing Slope (%)	N/A	N/A	DWS Length (in)	N/A			
N/A	Landing X Slope (%)	N/A	N/A	DWS Full Width?	N/A			
N/A	Landing Curb? (Y/N)	N/A	N/A	DWS Offset (in)	N/A			
N/A	Shared Landing?	N/A						
N/A	Gutter Ponding?	N/A	N/A	Gutter Slope (%)	N/A			
N/A	Gutter Lip Ht (in)	N/A	N/A	Gutter X Slope (%)	N/A			
N/A	Painted X Walk1?	No	N/A	Painted X Walk2?	N/A			
	X Walk 1 Direction	To SE		X Walk 2 Direction	N/A			
N/A	X Walk 1 Width (in)	N/A	N/A	X Walk 2 Width (in)	N/A

X Walk 1 Slope (%)	1.8		X Walk 2 Slope (%)	N/A			
	X Walk 1 X Slope (%)	0.5		X Walk 2 X Slope (%)	N/A			
N/A	Ramp inside XWalk1?	N/A	N/A	Ramp inside XWalk2?	N/A			
	Road Slope (%)	N/A	N/A	Clear Space?	N/A			
	Road X Slope (%)	N/A	N/A	Clear Space to XWalk (in)	N/A			
N/A	Any Obstructions?	N/A	N/A	Storm Grate/Utility Hazard?	N/A			
	Obstruction Type			Storm Grate/Utility Type				
		N/A			N/A			
The:			Yes	Surface Condition? (G/P)	Good

ш	1 033ibic 00idtioii
-	Possible Solutions:
	Remove & Replace Entire Ramp.
5	
ģ	
e e	Surveyor Notes:
	N/A
Contract of the last	
	PROW/ADA:
į	R304.2.2, R304.5.3
