## **Access Compliance Report Public Rights-of-Way** (Curb Ramps)

Intersection ID: 20485 Main Street: FAIRVIEW RD Cross Street: ASHLEY\_PARK\_LN Location: SE ADA ID: 4725E5DE734B Ramp Type: PerpDiag Initial Pass/Fail: Fail **Overall Compliance: No** Severity Score: 13.75

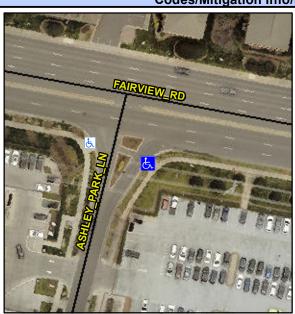
Field Measurements/Component Compliance							
	Compliance Description		Data	Compliance Description		Data	
	N/A	Ramp Length (in)	89.0	No	Ramp	Slope (%)	10.8
	Yes	Ramp Width (in)	48.0	No	Ramp	XSlope (%)	2.7
	N/A	Flare Type LT	N/A	N/A	Flare	Type RT	N/A
	N/A	Flare Slope LT (%)	N/A	N/A	Flare	Slope RT (%)	N/A
	N/A	Flare Traversable LT?	N/A	N/A	Flare	Traversable RT?	N/A
	N/A	Landing Length (in)	N/A	N/A	DWS	Provided?	N/A
	N/A	Landing Width (in)	N/A	N/A	DWS	Contrast?	N/A
	N/A	Landing Slope (%)	N/A	N/A	DWS	Length (in)	N/A
	N/A	Landing X Slope (%)	N/A	N/A	DWS	Full Width?	N/A
	N/A	Landing Curb? (Y/N)	N/A	N/A	DWS	Offset (in)	N/A
	N/A	Shared Landing?	N/A				
	N/A	Gutter Ponding?	N/A	N/A	Gutte	r Slope (%)	N/A
	N/A	Gutter Lip Ht (in)	N/A	N/A	Gutte	r X Slope (%)	N/A
	N/A	Painted X Walk1?	No	N/A	Paint	ed X Walk2?	No
		X Walk 1 Direction	To NE		X Wa	lk 2 Direction	To NW
	N/A	X Walk 1 Width (in)	N/A	N/A	X Wa	lk 2 Width (in)	N/A

X Walk 1 Slope (%)	4.0		X Wa	lk 2 Slope (%)	2.8
		X Walk 1 X Slope (%)	1.2		X Wa	lk 2 X Slope (%)	2.1
	N/A	Ramp inside XWalk1?	N/A	N/A	Ramp	inside XWalk2?	N/A
		Road Slope (%)	0.5	N/A	Clear	Space?	N/A
		Road X Slope (%)	1.4	N/A	Clear	Space to XWalk (in)	N/A
	N/A	Any Obstructions?	N/A	N/A	Storm	Grate/Utility Hazard?	N/A
		Obstruction Type			Storm	Grate/Utility Type	
			N/A				N/A
				Yes	Surfa	ce Condition? (G/P)	Good

Possible Solutions: **Remove & Replace Curb Ramp With** Two New Directional Ramps or Equivalent. Surveyor Notes: N/A PROW/ADA: R304.2.2, R304.5.3
