# Access Compliance Report

## Public Rights-of-Way

### (Curb Ramps)

| Intersection ID: 15725 | Main Street: CLANTON_RD | Cross Street: S_TRYON_ST | Location: SW |

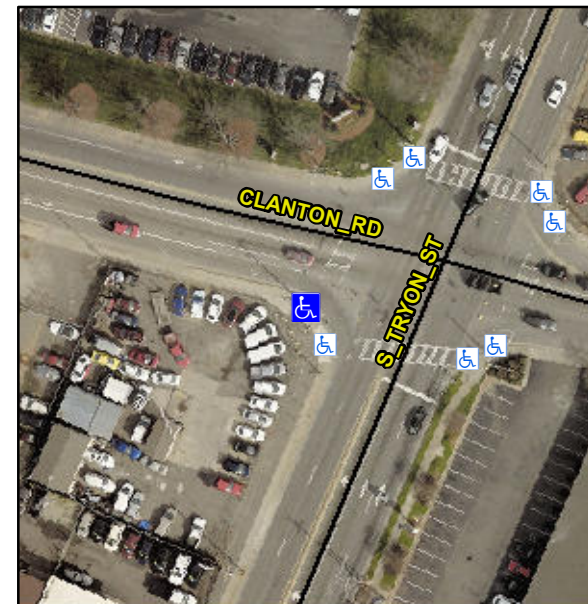
**Not Found, R304.2.2, R304.5.3**

| Compliance | Description | Data | Compliance | Description | Data |
|---|---|---|---|---|---|
| N/A | Ramp Length (in) | 72.0 | No | Ramp Slope (%) | 8.6 |
| Yes | Ramp Width (in) | 48.0 | No | Ramp XSlope (%) | 3.6 |

**Remove & Replace Entire Ramp.**
