# Access Compliance Report

## Public Rights-of-Way

### (Curb Ramps)

| Intersection ID: 53924 | Main Street: RORY_GLEN_LN | Cross Street: BRITTONDALE_LN | Location: W |

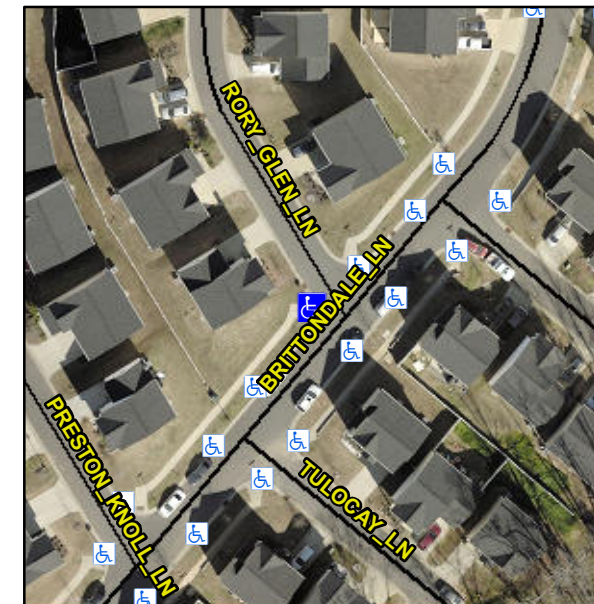
| ADA ID: 472B957FBAFD | Ramp Type: BlendTrans1 | Initial Pass/Fail: Fail | Overall Compliance: No |

**NO RT SW**

**Not Found, R304.5.1, R304.5.3**

| Compliance | Description | Data | Compliance | Description | Data |
|---|---|---|---|---|---|
| No | Ramp Width (in) | 40.0 | No | BlendTrans XSlope (%) | 4.5 |

**Remove & Replace Curb Ramp With Two New Directional Ramps or Equivalent.**

Total Cost: \$ 3200.00
