# Access Compliance Report

## Public Rights-of-Way

### (Curb Ramps)

Intersection ID: 3750	Main Street: DEER_CROSS_TL	Cross Street: HERITAGE_WOODS_PL	Location: NW
ADA ID: 47389EC02330	Ramp Type: Directional1	Initial Pass/Fail: Fail	Overall Compliance: No
		Severity Score: 8.75

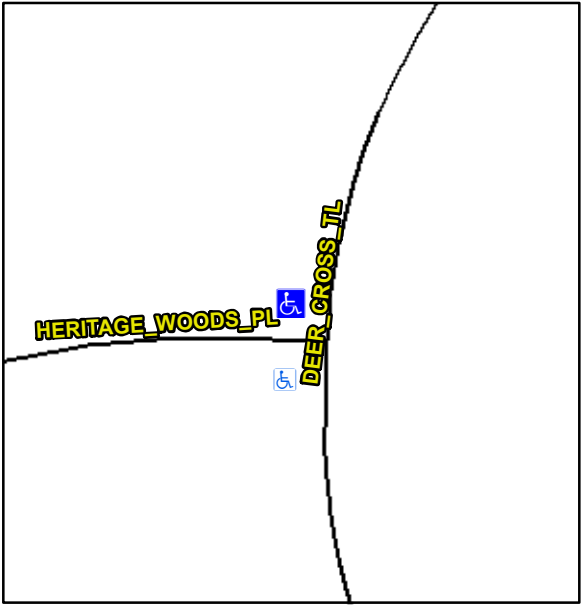
<p>Street 1 Name: HERITAGE WOODS PL</p> <p>Stop Condition-Street 1: StopSign</p> <p>Street 2 Name: N/A</p> <p>Stop Condition-Street 2: N/A</p>	<p>Possible Solutions:</p> <p><b>Remove &amp; Replace Entire Ramp.</b></p> <p>Surveyor Notes:</p> <p><b>N/A</b></p> <p>PROW/ADA:</p> <p><b>R304.5.1</b></p>	Compliance	Description	Data	Compliance	Description	Data
		N/A	Ramp Length (in)	66.0	N/A	Grade Break?	N/A
		No	Ramp Width (in)	38.0	N/A	Grade Break Slope (%)	0.0
		Yes	Ramp Slope (%)	5.1	N/A	Grade Break XSlope (%)	0.0
		Yes	Ramp XSlope (%)	1.1			
		N/A	Flare Type LT	N/A	N/A	Flare Type RT	N/A
		N/A	Flare Slope LT (%)	N/A	N/A	Flare Slope RT (%)	0.0
		N/A	Flare Traversable LT?	N/A	N/A	Flare Traversable RT?	N/A
		N/A	Landing Length (in)	0.0	N/A	DWS Provided?	N/A
		N/A	Landing Width (in)	0.0	N/A	DWS Contrast?	N/A
		N/A	Landing Slope (%)	0.0	N/A	DWS Length (in)	N/A

N/A	Landing X Slope (%)	0.0	N/A	DWS Full Width?	N/A
		N/A	Landing Curb? (Y/N)	N/A	N/A	DWS Offset LT (in)	N/A
		N/A	Shared Landing?	N/A	N/A	DWS Offset RT (in)	N/A
		N/A	Gutter Ponding?	0.0	N/A	Gutter Slope (%)	N/A
		N/A	Gutter Lip Ht (in)	0.0	N/A	Gutter X Slope (%)	N/A
		N/A	Painted X Walk1?	No		Road Slope (%)	0.5
			X Walk 1 Direction	To S		Road X Slope (%)	5.1
			X Walk 1 Width (in)	N/A		Clear Space?	N/A
			X Walk 1 Slope (%)	0.5	N/A	Clear Space to XWalk (in)	N/A
			X Walk 1 X Slope (%)	5.1	N/A	Storm Grate/Utility Hazard?	N/A
		N/A	Ramp inside XWalk1?	N/A		Storm Grate/Utility Type	
		N/A	Any Obstructions?	N/A			N/A
			Obstruction Type		Yes	Surface Condition? (G/P)	Good
					N/A	Curb Slope (%)	10.3
Total Cost:		\$	1600.00
