## **Access Compliance Report Public Rights-of-Way** (Curb Ramps)

Intersection ID: 14017 Main Street: STILWELL OAKS CR Cross Street: WILORA LAKE RD Location: SW **Overall Compliance: No** ADA ID: 47422D024C03 Ramp Type: BlendTrans1 Initial Pass/Fail: Fail Severity Score: 21.25

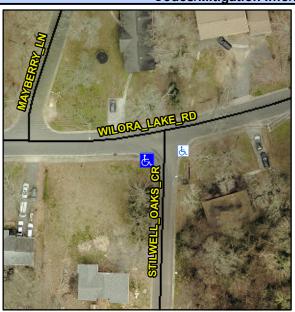
Total Cost: 3200.00 Compliance Description Data Compliance Description Data Ramp Length (in) Yes BlendTrans Slope (%) N/A 60.0 4.2 No No Ramp Width (in) 41.0 BlendTrans XSlope (%) 6.5 N/A N/A Flare Type LT N/A Flare Type RT N/A N/A Flare Slope LT (%) N/A N/A Flare Slope RT (%) N/A N/A Flare Traversable LT? N/A N/A Flare Traversable RT? N/A N/A Landing Length (in) N/A N/A **DWS Provided?** N/A N/A Landing Width (in) N/A N/A **DWS Contrast?** N/A N/A N/A N/A Landing Slope (%) DWS Length (in) N/A N/A Landing X Slope (%) N/A N/A DWS Full Width? N/A N/A Landing Curb? (Y/N) N/A N/A DWS Offset (in) N/A N/A N/A Shared Landing? N/A **Gutter Ponding?** N/A N/A Gutter Slope (%) N/A N/A Gutter Lip Ht (in) N/A N/A Gutter X Slope (%) N/A N/A Painted X Walk1? No N/A Painted X Walk2? N/A X Walk 1 Direction To E X Walk 2 Direction N/A N/A X Walk 2 Width (in) X Walk 1 Width (in) N/A X Walk 1 Slope (%) 0.3 X Walk 2 Slope (%) N/A X Walk 1 X Slope (%) 5.0 X Walk 2 X Slope (%) N/A N/A N/A Ramp inside XWalk2? N/A Ramp inside XWalk1? N/A Road Slope (%) 5.0 Clear Space? N/A Road X Slope (%) 0.3 N/A Clear Space to XWalk (in) N/A Any Obstructions? N/A N/A N/A Storm Grate/Utility Hazard? N/A **Obstruction Type** Storm Grate/Utility Type N/A N/A Yes Surface Condition? (G/P) Good No 26.0

STILLWELL OAKS CR Street 1 Name Stop Condition-Street 1 StopSign N/A Street 2 Name Stop Condition-Street 2 N/A Possible Solutions: Remove & Replace Curb Ramp With Two New Directional Ramps or Equivalent. Surveyor Notes: N/A PROW/ADA: Not Found, R304.5.1, R304.5.3
