# Access Compliance Report

## Public Rights-of-Way

### (Curb Ramps)

| Intersection ID: 14378 | Main Street: E_WORTHINGTON_AV | Cross Street: EUCLID_AV | Location: | N |

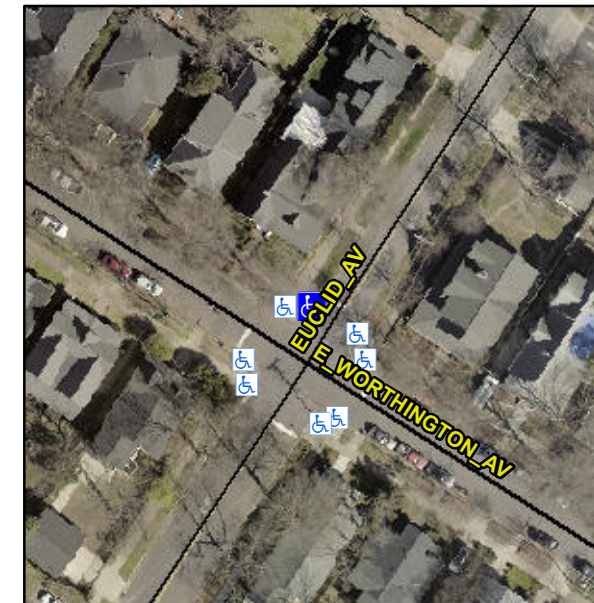
| ADA ID: 474F0C7D246A | Ramp Type: Perp | Initial Pass/Fail: Fail | Overall Compliance: No | Severity Score: 10 |

**Not Found, R304.5.1, R304.5.3**

| Compliance | Description | Data | Compliance | Description | Data |
|---|---|---|---|---|---|
| No | Ramp Width (in) | 42.0 | No | Ramp XSlope (%) | 2.7 |

**Remove & Replace Entire Ramp.**
