Access Compliance Report

Public Rights-of-Way

(Curb Ramps)

Intersection ID: 20587	Main Street: COLONY_RD	Cross Street: FAIRVIEW_RD	Location: NE
ADA ID: 4758923BE29B	Ramp Type: PerpDiag	Initial Pass/Fail: Fail	Overall Compliance: No
Severity Score: 12.5			
Codes/Mitigation Info/Possible Solution		Field Measurements/Component Compliance

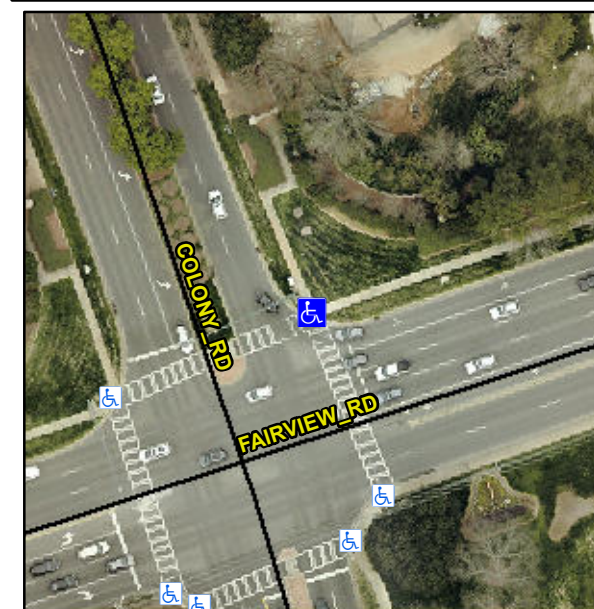
Compliance	Description	Data	Compliance	Description	Data
N/A	Ramp Length (in)	60.0	No	Ramp Slope (%)	9.6
Yes	Ramp Width (in)	48.0	Yes	Ramp XSlope (%)	0.8
N/A	Flare Type LT	N/A	N/A	Flare Type RT	N/A
N/A	Flare Slope LT (%)	N/A	N/A	Flare Slope RT (%)	N/A
N/A	Flare Traversable LT?	N/A	N/A	Flare Traversable RT?	N/A
N/A	Landing Length (in)	N/A	N/A	DWS Provided?	N/A
N/A	Landing Width (in)	N/A	N/A	DWS Contrast?	N/A
N/A	Landing Slope (%)	N/A	N/A	DWS Length (in)	N/A
N/A	Landing X Slope (%)	N/A	N/A	DWS Full Width?	N/A
N/A	Landing Curb? (Y/N)	N/A	N/A	DWS Offset (in)	N/A
N/A	Shared Landing?	N/A			
N/A	Gutter Ponding?	N/A	N/A	Gutter Slope (%)	N/A
N/A	Gutter Lip Ht (in)	N/A	N/A	Gutter X Slope (%)	N/A
N/A	Painted X Walk1?	Yes	N/A	Painted X Walk2?	Yes
	X Walk 1 Direction	To SW		X Walk 2 Direction	To SE
N/A	X Walk 1 Width (in)	112.0	N/A	X Walk 2 Width (in)	109.0
	X Walk 1 Slope (%)	3.3		X Walk 2 Slope (%)	1.6
	X Walk 1 X Slope (%)	0.8		X Walk 2 X Slope (%)	2.5

N/A	Ramp inside XWalk1?	Yes	N/A	Ramp inside XWalk2?	Yes
	Road Slope (%)	1.5	N/A	Clear Space?	N/A
	Road X Slope (%)	2.2	N/A	Clear Space to XWalk (in)	N/A
N/A	Any Obstructions?	N/A	N/A	Storm Grate/Utility Hazard?	N/A
	Obstruction Type			Storm Grate/Utility Type	
		N/A			N/A
		Yes		Surface Condition? (G/P)	Good

Possible Solutions:

Remove & Replace Curb Ramp With Two New Directional Ramps or Equivalent.
