Access Compliance Report

Public Rights-of-Way

(Curb Ramps)

Intersection ID: 11343	Main Street: KEMPTON_PL	Cross Street: KERN_ST	Location: NE
ADA ID: 476954327426	Ramp Type: Perp	Initial Pass/Fail: Fail	Overall Compliance: No
Codes/Mitigation Info/Possible Solution		Field Measurements/Component Compliance	
Severity Score: 12.5

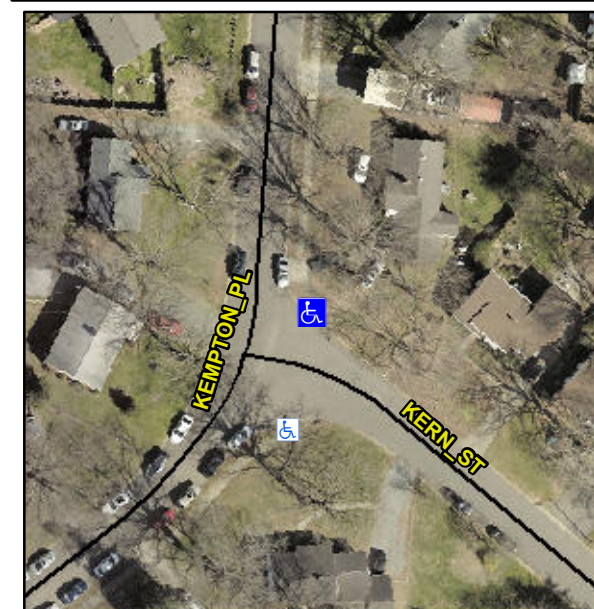
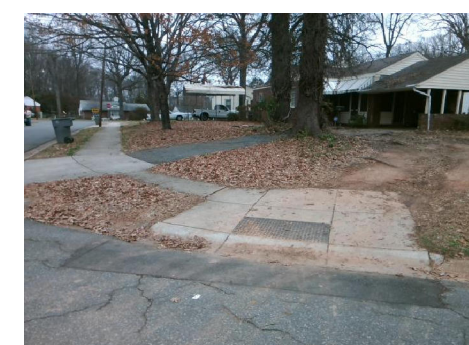
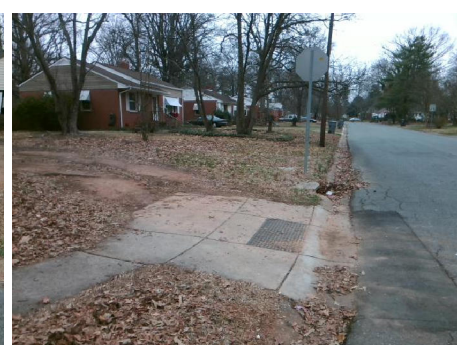
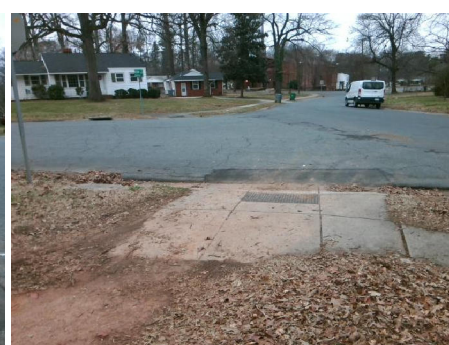
Not Found, R304.2.2

Compliance	Description	Data	Compliance	Description	Data
N/A	Ramp Length (in)	46.0	No	Ramp Slope (%)	8.6
Yes	Ramp Width (in)	48.0	Yes	Ramp XSlope (%)	0.1
N/A	Flare Type LT	N/A	N/A	Flare Type RT	N/A
N/A	Flare Slope LT (%)	N/A	N/A	Flare Slope RT (%)	N/A
N/A	Flare Traversable LT?	N/A	N/A	Flare Traversable RT?	N/A
N/A	Landing Length (in)	N/A	N/A	DWS Provided?	N/A
N/A	Landing Width (in)	N/A	N/A	DWS Contrast?	N/A
N/A	Landing Slope (%)	N/A	N/A	DWS Length (in)	N/A
N/A	Landing X Slope (%)	N/A	N/A	DWS Full Width?	N/A
N/A	Landing Curb? (Y/N)	N/A	N/A	DWS Offset (in)	N/A
N/A	Shared Landing?	N/A			
N/A	Gutter Ponding?	N/A	N/A	Gutter Slope (%)	N/A
N/A	Gutter Lip Ht (in)	N/A	N/A	Gutter X Slope (%)	N/A
N/A	Painted X Walk1?	No	N/A	Painted X Walk2?	N/A
	X Walk 1 Direction	To S		X Walk 2 Direction	N/A
N/A	X Walk 1 Width (in)	N/A	N/A	X Walk 2 Width (in)	N/A
	X Walk 1 Slope (%)	0.2		X Walk 2 Slope (%)	N/A
	X Walk 1 X Slope (%)	0.1		X Walk 2 X Slope (%)	N/A

N/A	Ramp inside XWalk1?	N/A	N/A	Ramp inside XWalk2?	N/A
	Road Slope (%)	N/A	N/A	Clear Space?	N/A
	Road X Slope (%)	N/A	N/A	Clear Space to XWalk (in)	N/A
N/A	Any Obstructions?	N/A	N/A	Storm Grate/Utility Hazard?	N/A
	Obstruction Type			Storm Grate/Utility Type	
		N/A			N/A
			Yes	Surface Condition? (G/P)	Good

Remove & Replace Entire Ramp.
