Access Compliance Report

Public Rights-of-Way

(Curb Ramps)

Intersection ID: 9172	Main Street: E_CRAIGHEAD_RD	Cross Street: N_TRYON_ST	Location: NE
ADA ID: 4778C22AE8C2	Ramp Type: Perp	Initial Pass/Fail: Fail	Overall Compliance: No
Severity Score: 21.25			
Codes/Mitigation Info/Possible Solution		Field Measurements/Component Compliance

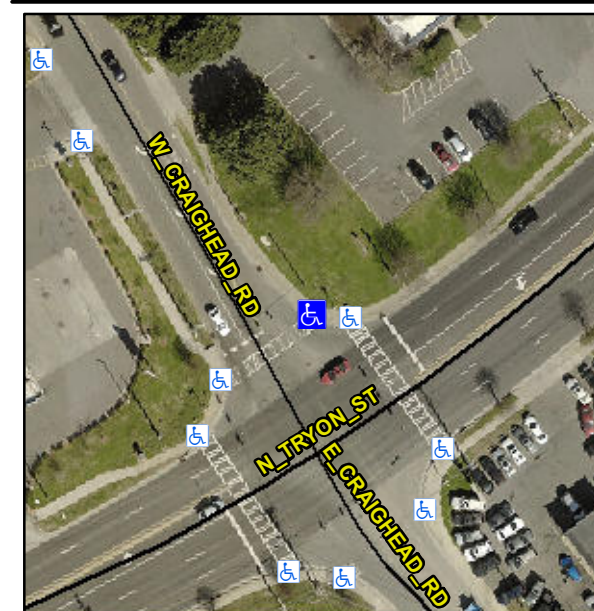
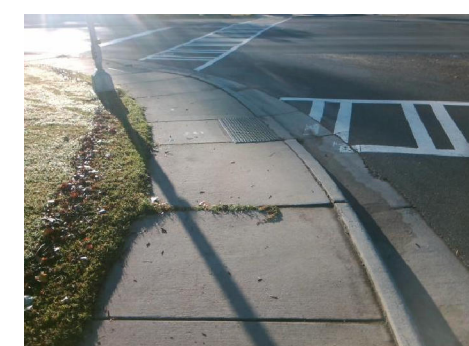
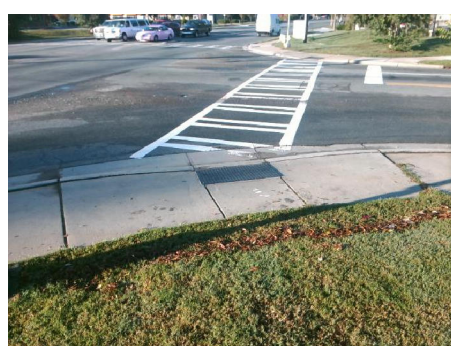
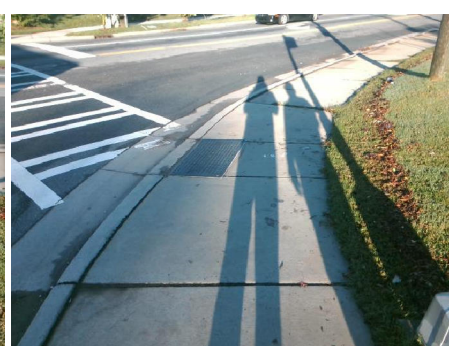
Not Found, R304.5.1, R304.2.2

Compliance	Description	Data	Compliance	Description	Data
N/A	Ramp Length (in)	72.0	No	Ramp Slope (%)	8.7
No	Ramp Width (in)	38.0	Yes	Ramp XSlope (%)	0.4
N/A	Flare Type LT	N/A	N/A	Flare Type RT	N/A
N/A	Flare Slope LT (%)	N/A	N/A	Flare Slope RT (%)	N/A
N/A	Flare Traversable LT?	N/A	N/A	Flare Traversable RT?	N/A
N/A	Landing Length (in)	N/A	N/A	DWS Provided?	N/A
N/A	Landing Width (in)	N/A	N/A	DWS Contrast?	N/A
N/A	Landing Slope (%)	N/A	N/A	DWS Length (in)	N/A
N/A	Landing X Slope (%)	N/A	N/A	DWS Full Width?	N/A
N/A	Landing Curb? (Y/N)	N/A	N/A	DWS Offset (in)	N/A
N/A	Shared Landing?	N/A			
N/A	Gutter Ponding?	N/A	N/A	Gutter Slope (%)	N/A
N/A	Gutter Lip Ht (in)	N/A	N/A	Gutter X Slope (%)	N/A
N/A	Painted X Walk1?	Yes	N/A	Painted X Walk2?	N/A
	X Walk 1 Direction	To SW		X Walk 2 Direction	N/A
N/A	X Walk 1 Width (in)	80.5	N/A	X Walk 2 Width (in)	N/A
	X Walk 1 Slope (%)	0.0		X Walk 2 Slope (%)	N/A
	X Walk 1 X Slope (%)	0.3		X Walk 2 X Slope (%)	N/A

N/A	Ramp inside XWalk1?	Yes	N/A	Ramp inside XWalk2?	N/A
	Road Slope (%)	N/A	N/A	Clear Space?	N/A
	Road X Slope (%)	N/A	N/A	Clear Space to XWalk (in)	N/A
N/A	Any Obstructions?	N/A	N/A	Storm Grate/Utility Hazard?	N/A
	Obstruction Type			Storm Grate/Utility Type	
		N/A			N/A
		Yes		Surface Condition? (G/P)	Good

Remove & Replace Entire Ramp.

Total Cost: \$ 1850.00
