Access Compliance Report

Public Rights-of-Way

(Curb Ramps)

| Intersection ID: 42931 | Main Street: BRAY_DR | Cross Street: HOLLY_PARK_DR | Location: W |

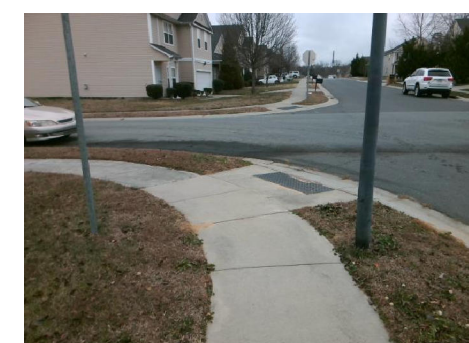
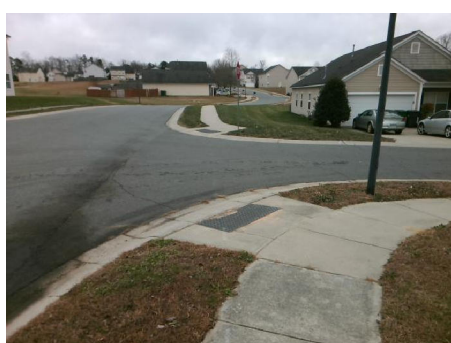
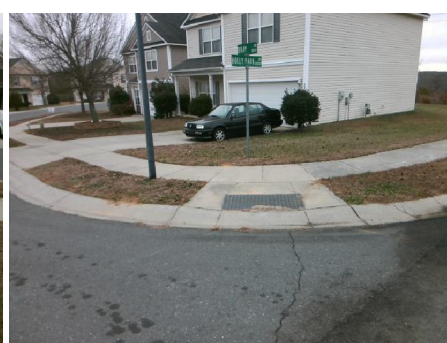
| ADA ID: 477A4EC35B38 | Ramp Type: PerpDiag | Initial Pass/Fail: Fail | Overall Compliance: No |
| Severity Score: 8.75 | | | |

Not Found, R304.5.1

| Compliance | Description | Data | Compliance | Description | Data |
|---|---|---|---|---|---|
| No | Ramp Width (in) | 37.0 | Yes | Ramp XSlope (%) | 0.3 |

Remove & Replace Curb Ramp With Two New Directional Ramps or Equivalent.
