# Access Compliance Report

## Public Rights-of-Way

### (Curb Ramps)

Intersection ID: 9838	Main Street: AINTREE_RD	Cross Street: THE_PLAZA	Location: SE
ADA ID: 477ADF5A0EBB	Ramp Type: Perp	Initial Pass/Fail: Fail	Overall Compliance: No
Severity Score: 1.25			
Codes/Mitigation Info/Possible Solution		Field Measurements/Component Compliance

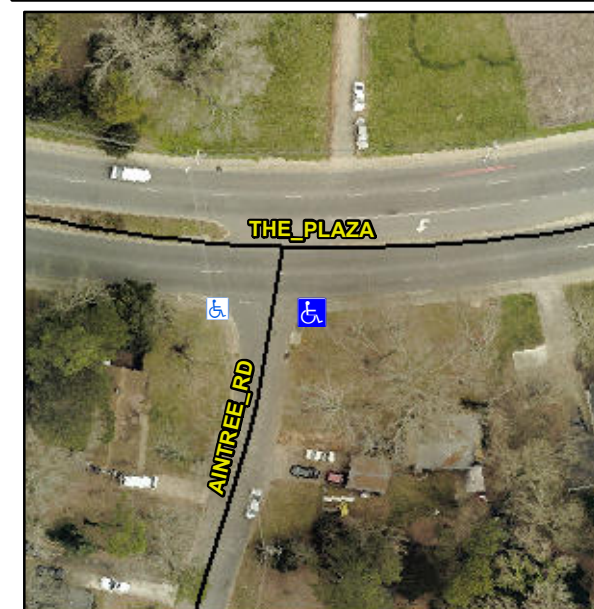
**Not Found, R304.5.3**

Compliance	Description	Data	Compliance	Description	Data
N/A	Ramp Length (in)	60.0	Yes	Ramp Slope (%)	6.8
Yes	Ramp Width (in)	48.0	No	Ramp XSlope (%)	2.7
N/A	Flare Type LT	N/A	N/A	Flare Type RT	N/A
N/A	Flare Slope LT (%)	N/A	N/A	Flare Slope RT (%)	N/A
N/A	Flare Traversable LT?	N/A	N/A	Flare Traversable RT?	N/A
N/A	Landing Length (in)	N/A	N/A	DWS Provided?	N/A
N/A	Landing Width (in)	N/A	N/A	DWS Contrast?	N/A
N/A	Landing Slope (%)	N/A	N/A	DWS Length (in)	N/A
N/A	Landing X Slope (%)	N/A	N/A	DWS Full Width?	N/A
N/A	Landing Curb? (Y/N)	N/A	N/A	DWS Offset (in)	N/A
N/A	Shared Landing?	N/A			
N/A	Gutter Ponding?	N/A	N/A	Gutter Slope (%)	N/A
N/A	Gutter Lip Ht (in)	2.0	N/A	Gutter X Slope (%)	N/A
N/A	Painted X Walk1?	No	N/A	Painted X Walk2?	N/A
	X Walk 1 Direction	To W		X Walk 2 Direction	N/A
N/A	X Walk 1 Width (in)	N/A	N/A	X Walk 2 Width (in)	N/A
	X Walk 1 Slope (%)	2.3		X Walk 2 Slope (%)	N/A
	X Walk 1 X Slope (%)	2.7		X Walk 2 X Slope (%)	N/A

**Remove & Replace Entire Ramp.**

Total Cost: \$ 1850.00
