Access Compliance Report

Public Rights-of-Way

(Curb Ramps)

Intersection ID: 30149	Main Street: RUMPLE_RD	Cross Street: HEMBY_WOODS_DR	Location: N
ADA ID: 477CF599EAD2	Ramp Type: PerpDiag	Initial Pass/Fail: Fail	Overall Compliance: No
Severity Score: 33.75			
Codes/Mitigation Info/Possible Solution		Field Measurements/Component Compliance

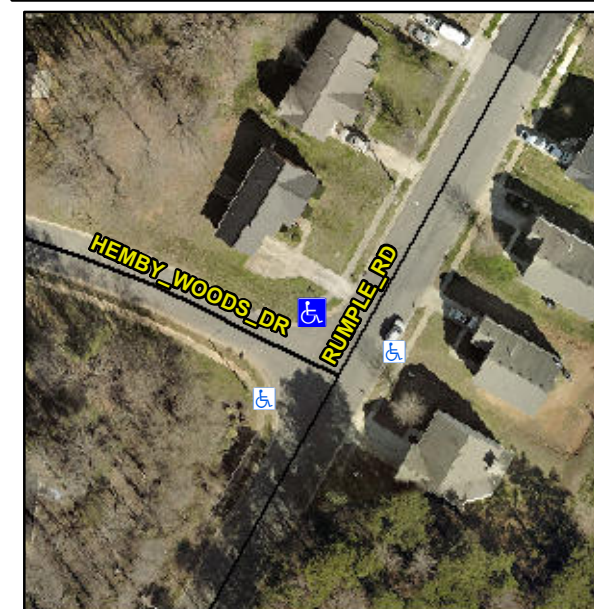
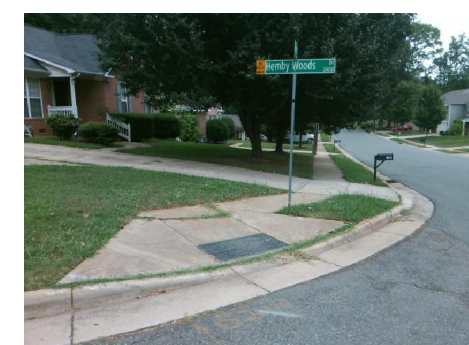
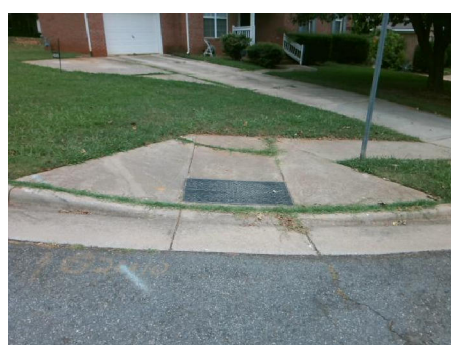
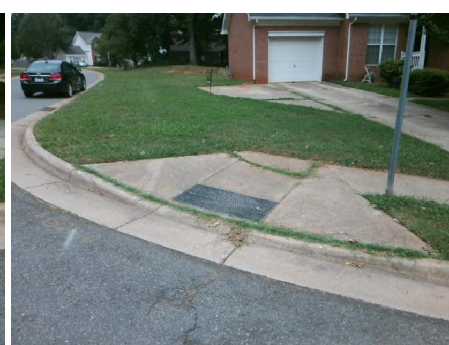
Not Found, R304.5.1, R304.5.3

Compliance	Description	Data	Compliance	Description	Data
N/A	Ramp Length (in)	95.0	Yes	Ramp Slope (%)	6.8
No	Ramp Width (in)	46.5	No	Ramp XSlope (%)	7.6
N/A	Flare Type LT	N/A	N/A	Flare Type RT	N/A
N/A	Flare Slope LT (%)	N/A	N/A	Flare Slope RT (%)	N/A
N/A	Flare Traversable LT?	N/A	N/A	Flare Traversable RT?	N/A
N/A	Landing Length (in)	N/A	N/A	DWS Provided?	N/A
N/A	Landing Width (in)	N/A	N/A	DWS Contrast?	N/A
N/A	Landing Slope (%)	N/A	N/A	DWS Length (in)	N/A
N/A	Landing X Slope (%)	N/A	N/A	DWS Full Width?	N/A
N/A	Landing Curb? (Y/N)	N/A	N/A	DWS Offset (in)	N/A
N/A	Shared Landing?	N/A			
N/A	Gutter Ponding?	N/A	N/A	Gutter Slope (%)	N/A
N/A	Gutter Lip Ht (in)	N/A	N/A	Gutter X Slope (%)	N/A
N/A	Painted X Walk1?	No	N/A	Painted X Walk2?	No
	X Walk 1 Direction	To SW		X Walk 2 Direction	To SE
N/A	X Walk 1 Width (in)	N/A	N/A	X Walk 2 Width (in)	N/A
	X Walk 1 Slope (%)	7.6		X Walk 2 Slope (%)	0.4
	X Walk 1 X Slope (%)	1.3		X Walk 2 X Slope (%)	4.8

N/A	Ramp inside XWalk1?	N/A	N/A	Ramp inside XWalk2?	N/A
	Road Slope (%)	6.8	N/A	Clear Space?	N/A
	Road X Slope (%)	1.7	N/A	Clear Space to XWalk (in)	N/A
N/A	Any Obstructions?	N/A	N/A	Storm Grate/Utility Hazard?	N/A
	Obstruction Type			Storm Grate/Utility Type	
		N/A			N/A
		Yes		Surface Condition? (G/P)	Good

Possible Solutions:

Remove & Replace Curb Ramp With Two New Directional Ramps or Equivalent.
