# Access Compliance Report

## Public Rights-of-Way

### (Curb Ramps)

| Intersection ID: 48770 | Main Street: TURNING_WHEEL_DR | Cross Street: KNOTHOLE_LN | Location: NE |

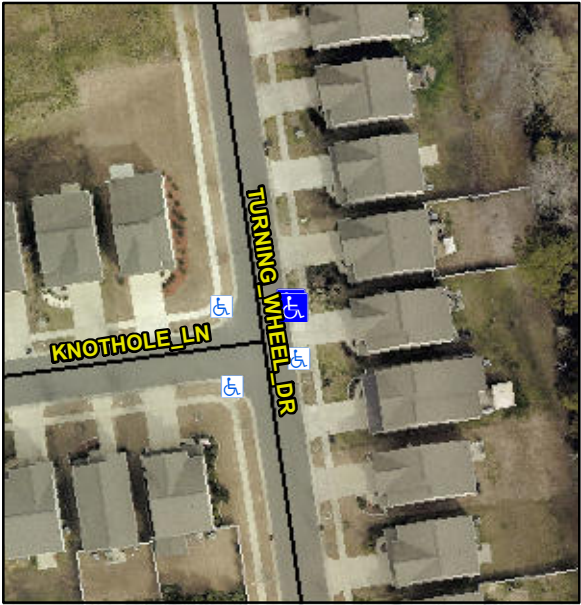
| ADA ID: 4780BCE347B2 | Ramp Type: Perp | Initial Pass/Fail: Fail | Overall Compliance: No |
| Severity Score: 13.75 | | | |

| | Remove & Replace Entire Ramp. | N/A | Ramp Length (in) | 72.0 | No | Ramp Slope (%) | 8.8 |
| | | Yes | Ramp Width (in) | 48.0 | No | Ramp XSlope (%) | 2.1 |
| <p>Surveyor Notes:</p> <p>N/A</p> <p>PROW/ADA:</p> <p>Not Found, R304.2.2, R304.5.3</p> | | | Road Slope (%) | N/A | N/A | Clear Space? | N/A |

| | Possible Solutions: | Compliance | Description | Data | Compliance | Description | Data |
