# Access Compliance Report

## Public Rights-of-Way

### (Curb Ramps)

| Intersection ID: 14652 | Main Street: DRIFTWOOD_DR | Cross Street: MCMANUS_DR | Location: SW |

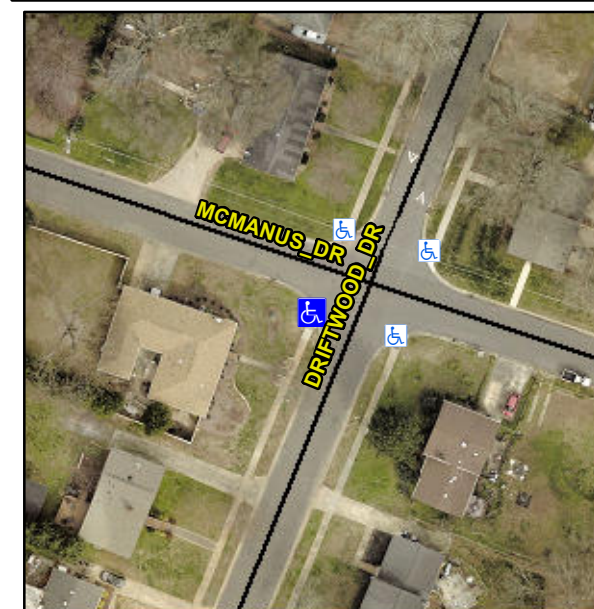
| Compliance | Description | Data | Compliance | Description | Data |
| Yes | Ramp Slope (%) | 3.4 | No | Grade Break XSlope (%) | 3.6 |
| No | Ramp XSlope (%) | 3.7 | | | |
| Yes | Landing X Slope (%) | 1.8 | No | DWS Full Width? | No |
| N/A | Landing Curb? (Y/N) | No | No | DWS Offset LT (in) | 3.0 |

Possible Solutions:

**Remove & Replace Entire Ramp.**

**R304.5.3, R305.1.4, R305.2**
