# Access Compliance Report

## Public Rights-of-Way

### (Curb Ramps)

| Intersection ID: 5858 | Main Street: CARMENET_LN | Cross Street: LONG_PAW_LN | Location: SW |

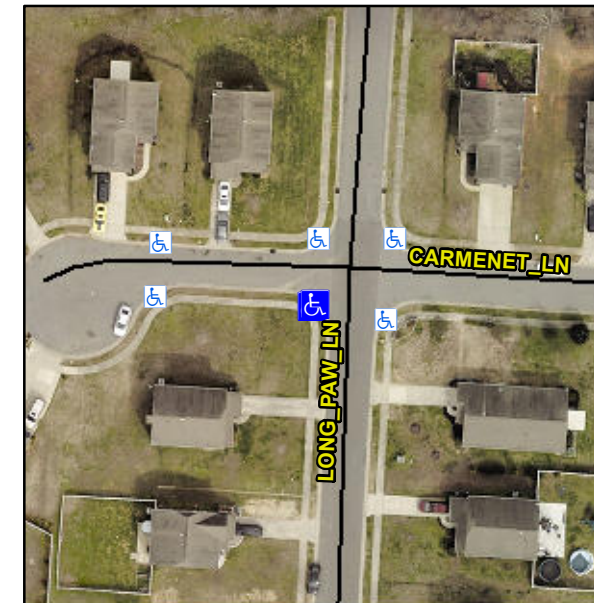
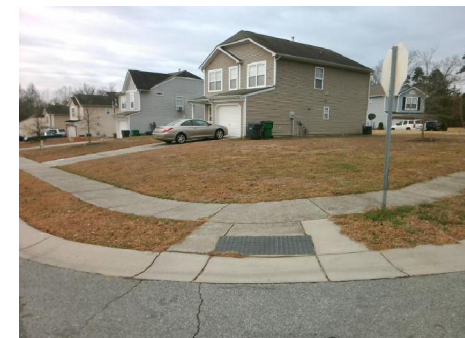
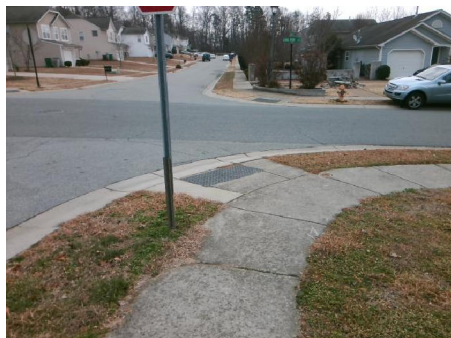
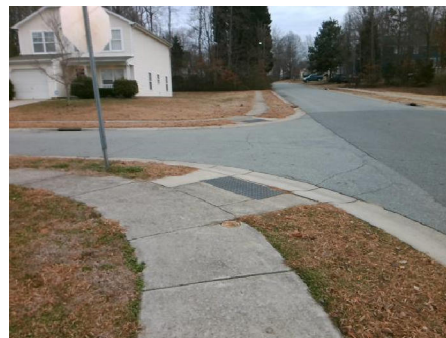
| ADA ID: 478719076EFF | Ramp Type: BlendTrans1 | Initial Pass/Fail: Fail | Overall Compliance: No |

| | | Severity Score: 10 | |

**Not Found, R304.5.1, R304.5.3**

| Compliance | Description | Data | Compliance | Description | Data |
|---|---|---|---|---|---|
| No | Ramp Width (in) | 39.0 | No | BlendTrans XSlope (%) | 4.7 |
| | | | No | Curb Slope (%) | 16.3 |

**Remove & Replace Curb Ramp With Two New Directional Ramps or Equivalent.**

Total Cost: \$ 3200.00
