Access Compliance Report

Public Rights-of-Way

(Curb Ramps)

Intersection ID: 48740	Main Street: HEDGEWYCK_PL	Cross Street: SHARON_RD	Location: SE
ADA ID: 47955A579D6C	Ramp Type: PerpDiag	Initial Pass/Fail: Fail	Overall Compliance: No
Severity Score: 37.5			
Codes/Mitigation Info/Possible Solution		Field Measurements/Component Compliance

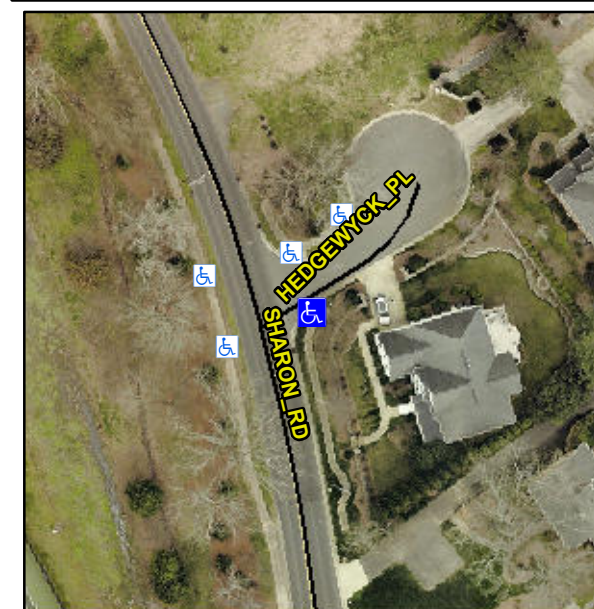
Compliance	Description	Data	Compliance	Description	Data
N/A	Ramp Length (in)	48.0	No	Ramp Slope (%)	10.1
Yes	Ramp Width (in)	48.0	No	Ramp XSlope (%)	9.7
N/A	Flare Type LT	N/A	N/A	Flare Type RT	N/A
N/A	Flare Slope LT (%)	N/A	N/A	Flare Slope RT (%)	N/A
N/A	Flare Traversable LT?	N/A	N/A	Flare Traversable RT?	N/A
N/A	Landing Length (in)	N/A	N/A	DWS Provided?	N/A
N/A	Landing Width (in)	N/A	N/A	DWS Contrast?	N/A
N/A	Landing Slope (%)	N/A	N/A	DWS Length (in)	N/A
N/A	Landing X Slope (%)	N/A	N/A	DWS Full Width?	N/A
N/A	Landing Curb? (Y/N)	N/A	N/A	DWS Offset (in)	N/A
N/A	Shared Landing?	N/A			
N/A	Gutter Ponding?	N/A	N/A	Gutter Slope (%)	N/A
N/A	Gutter Lip Ht (in)	N/A	N/A	Gutter X Slope (%)	N/A
N/A	Painted X Walk1?	No	N/A	Painted X Walk2?	No
	X Walk 1 Direction	To N		X Walk 2 Direction	To W
N/A	X Walk 1 Width (in)	N/A	N/A	X Walk 2 Width (in)	N/A
	X Walk 1 Slope (%)	3.5		X Walk 2 Slope (%)	9.0
	X Walk 1 X Slope (%)	11.7		X Walk 2 X Slope (%)	1.2

N/A	Ramp inside XWalk1?	N/A	N/A	Ramp inside XWalk2?	N/A
	Road Slope (%)	9.0	N/A	Clear Space?	N/A
	Road X Slope (%)	5.5	N/A	Clear Space to XWalk (in)	N/A
N/A	Any Obstructions?	N/A	N/A	Storm Grate/Utility Hazard?	N/A
	Obstruction Type			Storm Grate/Utility Type	
		N/A			N/A
			Yes	Surface Condition? (G/P)	Good

Remove & Replace Curb Ramp With Two New Directional Ramps or Equivalent.

R304.2.2, R304.5.3
