Access Compliance Report

Public Rights-of-Way

(Curb Ramps)

Intersection ID: 11978	Main Street: WILSON_AV	Cross Street: BEAUX_ST	Location: E
ADA ID: 47998DE9E4DE	Ramp Type: BlendTrans1	Initial Pass/Fail: Pass	Overall Compliance: No
		Severity Score: 0

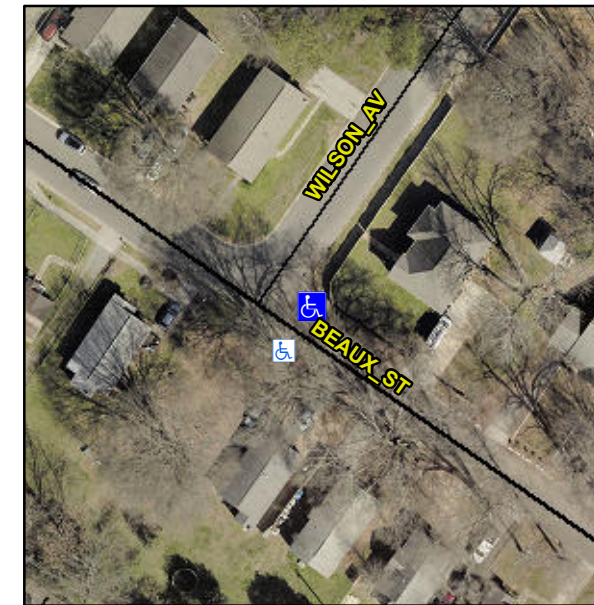
NO RT SW

Not Found, R305.2

Compliance	Description	Data	Compliance	Description	Data
N/A	Ramp Length (in)	48.0	Yes	BlendTrans Slope (%)	3.2
Yes	Ramp Width (in)	48.0	Yes	BlendTrans XSlope (%)	0.6
N/A	Flare Type LT	Sloped	N/A	Flare Type RT	Sloped
N/A	Flare Slope LT (%)	1.8	N/A	Flare Slope RT (%)	5.9
N/A	Flare Traversable LT?	No	N/A	Flare Traversable RT?	No
Yes	Landing Length (in)	60.0	Yes	DWS Provided?	Yes
Yes	Landing Width (in)	48.0	Yes	DWS Contrast?	Yes
Yes	Landing Slope (%)	1.6	Yes	DWS Length (in)	24.0
Yes	Landing X Slope (%)	1.9	Yes	DWS Full Width?	Yes
N/A	Landing Curb? (Y/N)	No	No	DWS Offset (in)	5.5
N/A	Shared Landing?	No			
Yes	Gutter Ponding?	No	Yes	Gutter Slope (%)	1.3
Yes	Gutter Lip Ht (in)	0.0	Yes	Gutter X Slope (%)	1.9
N/A	Painted X Walk1?	No	N/A	Painted X Walk2?	N/A
	X Walk 1 Direction	To SW		X Walk 2 Direction	N/A
	X Walk 1 Width (in)	N/A		X Walk 2 Width (in)	N/A
	X Walk 1 Slope (%)	2.3		X Walk 2 Slope (%)	N/A
	X Walk 1 X Slope (%)	1.0		X Walk 2 X Slope (%)	N/A

N/A	Ramp inside XWalk1?	N/A	N/A	Ramp inside XWalk2?	N/A
	Road Slope (%)	1.0		Clear Space?	Yes
	Road X Slope (%)	2.3	N/A	Clear Space to XWalk (in)	N/A
Yes	Any Obstructions?	No	Yes	Storm Grate/Utility Hazard?	No
	Obstruction Type			Storm Grate/Utility Type	
		N/A			N/A
			Yes	Surface Condition? (G/P)	Good
			No	Curb Slope (%)	9.8

Remove & Replace Curb Ramp With Two New Directional Ramps or Equivalent.
