## Access Compliance Report Public Rights-of-Way (Curb Ramps)

Intersection ID: 10021322 Main Street: BLAKENEY\_GREENS\_BV Cross Street: N/A Location: SE

ADA ID: 4799CF0FBC6F Ramp Type: PerpDiag Initial Pass/Fail: Fail Overall Compliance: No Severity Score: 12.5

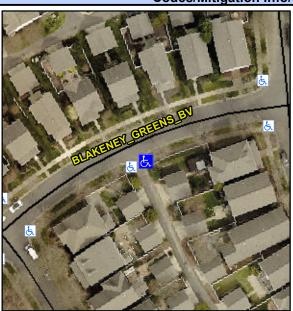
N/A	Ramp Length (in)	66.0	No	Ramp Slope (%)
Yes	Ramp Width (in)	48.0	Yes	Ramp XSlope (%)
N/A	Flare Type LT	N/A	N/A	Flare Type RT
N/A	Flare Slope LT (%)	N/A	N/A	Flare Slope RT (%)
N/A	Flare Traversable LT?	N/A	N/A	Flare Traversable RT?
N/A	Landing Length (in)	N/A	N/A	DWS Provided?
N/A	Landing Width (in)	N/A	N/A	DWS Contrast?
N/A	Landing Slope (%)	N/A	N/A	DWS Length (in)
N/A	Landing X Slope (%)	N/A	N/A	DWS Full Width?
N/A	Landing Curb? (Y/N)	N/A	N/A	DWS Offset (in)
N/A	Shared Landing?	N/A		
N/A	Gutter Ponding?	N/A	N/A	Gutter Slope (%)
N/A	Gutter Lip Ht (in)	N/A	N/A	Gutter X Slope (%)
N/A	Painted X Walk1?	No	N/A	Painted X Walk2?
	X Walk 1 Direction	To SW		X Walk 2 Direction
N/A	X Walk 1 Width (in)	N/A	N/A	X Walk 2 Width (in)
	X Walk 1 Slope (%)	0.5		X Walk 2 Slope (%)
	X Walk 1 X Slope (%)	2.2		X Walk 2 X Slope (%)
N/A	Ramp inside XWalk1?	N/A	N/A	Ramp inside XWalk2?
	Road Slope (%)	0.2	N/A	Clear Space?
	Road X Slope (%)	1.9	N/A	Clear Space to XWalk (in)

POSSIBLE SOLUTION
Possible Solutions:
Remove & Replace Curb Ramp With Two New Directional Ramps or Equivalent.
Surveyor Notes: N/A
PROW/ADA: R304.2.2

PROW/ADA: R304.2.2		 
Total Cost:	\$ 3200.00
