Access Compliance Report

Public Rights-of-Way

(Curb Ramps)

Intersection ID: 23547	Main Street: CASTLEGATE_DR	Cross Street: KNIGHTSWOOD_DR	Location: NE
ADA ID: 479F648D3DB7	Ramp Type: BlendTrans2	Initial Pass/Fail: Fail	Overall Compliance: No
Severity Score: 8.75			
Codes/Mitigation Info/Possible Solution		Field Measurements/Component Compliance

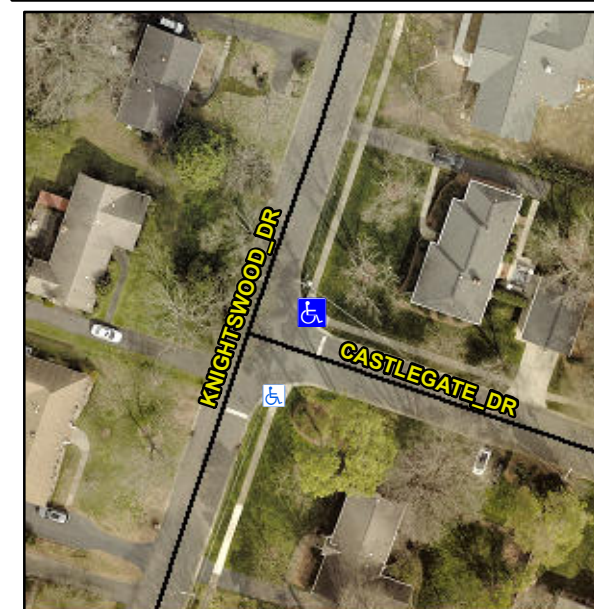
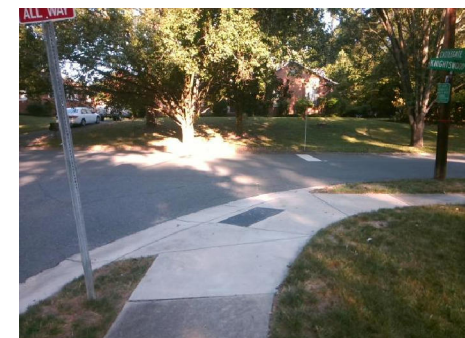
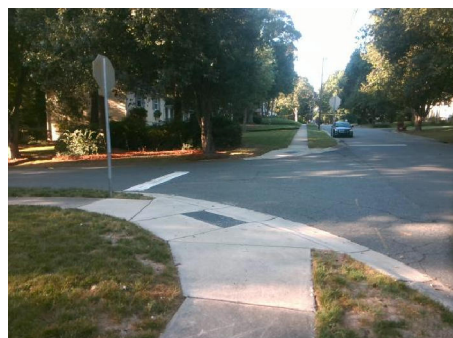
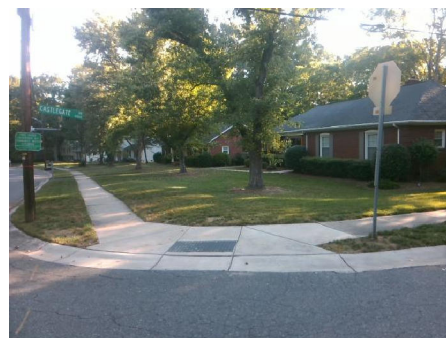
Not Found, R304.5.1

Compliance	Description	Data	Compliance	Description	Data
N/A	Ramp Length (in)	73.0	Yes	BlendTrans Slope (%)	4.2
No	Ramp Width (in)	47.0	Yes	BlendTrans XSlope (%)	1.0
N/A	Flare Type LT	N/A	N/A	Flare Type RT	N/A
N/A	Flare Slope LT (%)	N/A	N/A	Flare Slope RT (%)	N/A
N/A	Flare Traversable LT?	N/A	N/A	Flare Traversable RT?	N/A
N/A	Landing Length (in)	N/A	N/A	DWS Provided?	N/A
N/A	Landing Width (in)	N/A	N/A	DWS Contrast?	N/A
N/A	Landing Slope (%)	N/A	N/A	DWS Length (in)	N/A
N/A	Landing X Slope (%)	N/A	N/A	DWS Full Width?	N/A
N/A	Landing Curb? (Y/N)	N/A	N/A	DWS Offset (in)	N/A
N/A	Shared Landing?	N/A			
N/A	Gutter Ponding?	N/A	N/A	Gutter Slope (%)	N/A
N/A	Gutter Lip Ht (in)	N/A	N/A	Gutter X Slope (%)	N/A
N/A	Painted X Walk1?	No	N/A	Painted X Walk2?	No
	X Walk 1 Direction	To NW		X Walk 2 Direction	To SW
	X Walk 1 Width (in)	N/A		X Walk 2 Width (in)	N/A
	X Walk 1 Slope (%)	2.3		X Walk 2 Slope (%)	2.9
	X Walk 1 X Slope (%)	7.0		X Walk 2 X Slope (%)	3.1

N/A	Ramp inside XWalk1?	N/A	N/A	Ramp inside XWalk2?	N/A
	Road Slope (%)	1.5		Clear Space?	N/A
	Road X Slope (%)	6.2	N/A	Clear Space to XWalk (in)	N/A
N/A	Any Obstructions?	N/A	N/A	Storm Grate/Utility Hazard?	N/A
	Obstruction Type			Storm Grate/Utility Type	
		N/A			N/A
			Yes	Surface Condition? (G/P)	Good
			No	Curb Slope (%)	7.8

Remove & Replace Curb Ramp With Two New Directional Ramps or Equivalent.
