Access Compliance Report

Public Rights-of-Way

(Curb Ramps)

Intersection ID: 20575	Main Street: SANDY_PORTER_RD	Cross Street: SHERMAN_DR	Location: S
ADA ID: 479F6D205D40	Ramp Type: Directional1	Initial Pass/Fail: Fail	Overall Compliance: No
			Severity Score: 21.25

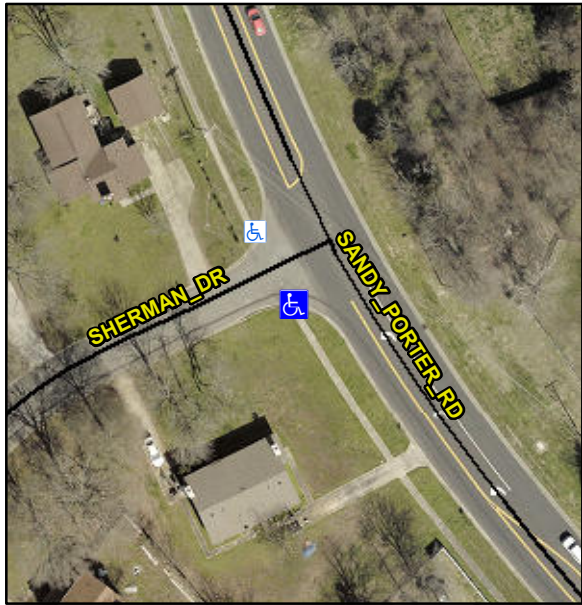
Possible Solutions:		Compliance	Description	Data	Compliance	Description	Data
	Remove & Replace Entire Ramp.		N/A	Ramp Length (in)	32.0	N/A	Grade Break?	N/A
			No	Ramp Width (in)	43.0	N/A	Grade Break Slope (%)	0.0
			No	Ramp Slope (%)	9.2	N/A	Grade Break XSlope (%)	0.0
			Yes	Ramp XSlope (%)	0.9			
			N/A	Flare Type LT	N/A	N/A	Flare Type RT	N/A
			N/A	Flare Slope LT (%)	N/A	N/A	Flare Slope RT (%)	0.0
			N/A	Flare Traversable LT?	N/A	N/A	Flare Traversable RT?	N/A
			N/A	Landing Length (in)	0.0	N/A	DWS Provided?	N/A
			N/A	Landing Width (in)	0.0	N/A	DWS Contrast?	N/A
Surveyor Notes:			N/A	Landing Slope (%)	0.0	N/A	DWS Length (in)	N/A
N/A			N/A	Landing X Slope (%)	0.0	N/A	DWS Full Width?	N/A
PROW/ADA:			N/A	Landing Curb? (Y/N)	N/A	N/A	DWS Offset LT (in)	N/A
R304.5.1, R304.2.2			N/A	Shared Landing?	N/A	N/A	DWS Offset RT (in)	N/A

N/A	Gutter Ponding?	0.0	N/A	Gutter Slope (%)	N/A
			N/A	Gutter Lip Ht (in)	0.0	N/A	Gutter X Slope (%)	N/A
			N/A	Painted X Walk1?	No		Road Slope (%)	4.4
				X Walk 1 Direction	To NW		Road X Slope (%)	1.6
				X Walk 1 Width (in)	N/A		Clear Space?	N/A
				X Walk 1 Slope (%)	4.4	N/A	Clear Space to XWalk (in)	N/A
				X Walk 1 X Slope (%)	1.6	N/A	Storm Grate/Utility Hazard?	N/A
			N/A	Ramp inside XWalk1?	N/A		Storm Grate/Utility Type	
			N/A	Any Obstructions?	N/A			N/A
				Obstruction Type		N/A	Surface Condition? (G/P)	N/A
						N/A	Curb Slope (%)	27.0
Street 1 Name		SHERMAN DR						
Stop Condition-Street 1		StopSign						
Street 2 Name		N/A						
Stop Condition-Street 2		N/A						
Total Cost:		\$ 1600.00
