Access Compliance Report

Public Rights-of-Way

(Curb Ramps)

Intersection ID: 46491	Main Street: BERE_ISLAND_DR	Cross Street: CASTLECOVE_RD	Location: SW
ADA ID: 47A2A88106C0	Ramp Type: PerpDiag	Initial Pass/Fail: Fail	Overall Compliance: No
Severity Score: 10			
Codes/Mitigation Info/Possible Solution		Field Measurements/Component Compliance

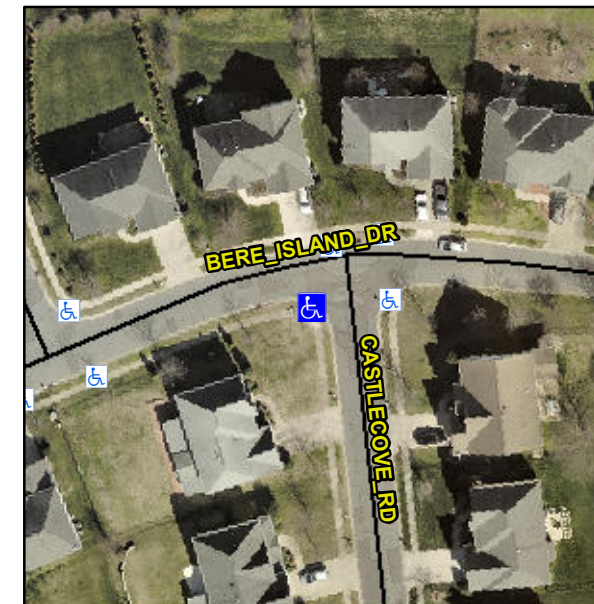
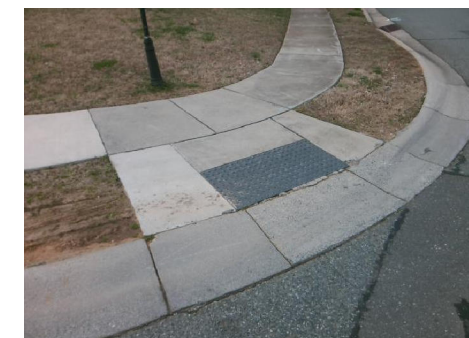
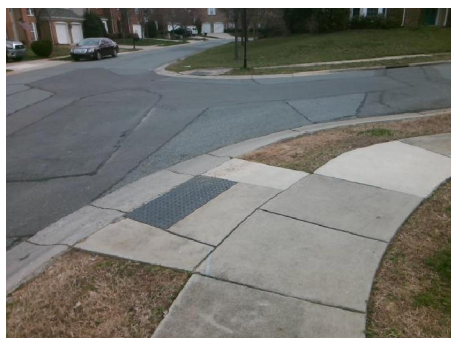
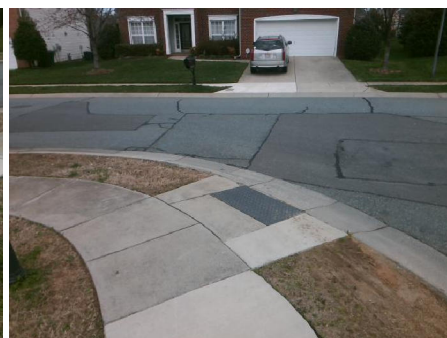
Not Found, R304.5.1, R304.5.3

Compliance	Description	Data	Compliance	Description	Data
N/A	Ramp Length (in)	47.0	Yes	Ramp Slope (%)	5.2
No	Ramp Width (in)	41.0	No	Ramp XSlope (%)	4.9
N/A	Flare Type LT	N/A	N/A	Flare Type RT	N/A
N/A	Flare Slope LT (%)	N/A	N/A	Flare Slope RT (%)	N/A
N/A	Flare Traversable LT?	N/A	N/A	Flare Traversable RT?	N/A
N/A	Landing Length (in)	N/A	N/A	DWS Provided?	N/A
N/A	Landing Width (in)	N/A	N/A	DWS Contrast?	N/A
N/A	Landing Slope (%)	N/A	N/A	DWS Length (in)	N/A
N/A	Landing X Slope (%)	N/A	N/A	DWS Full Width?	N/A
N/A	Landing Curb? (Y/N)	N/A	N/A	DWS Offset (in)	N/A
N/A	Shared Landing?	N/A			
N/A	Gutter Ponding?	N/A	N/A	Gutter Slope (%)	N/A
N/A	Gutter Lip Ht (in)	N/A	N/A	Gutter X Slope (%)	N/A
N/A	Painted X Walk1?	No	N/A	Painted X Walk2?	No
	X Walk 1 Direction	To E		X Walk 2 Direction	To N
N/A	X Walk 1 Width (in)	N/A	N/A	X Walk 2 Width (in)	N/A
	X Walk 1 Slope (%)	1.4		X Walk 2 Slope (%)	1.8
	X Walk 1 X Slope (%)	4.1		X Walk 2 X Slope (%)	0.9

N/A	Ramp inside XWalk1?	N/A	N/A	Ramp inside XWalk2?	N/A
	Road Slope (%)	3.6	N/A	Clear Space?	N/A
	Road X Slope (%)	1.2	N/A	Clear Space to XWalk (in)	N/A
N/A	Any Obstructions?	N/A	N/A	Storm Grate/Utility Hazard?	N/A
	Obstruction Type			Storm Grate/Utility Type	
		N/A			N/A
		Yes		Surface Condition? (G/P)	Good

Remove & Replace Curb Ramp With Two New Directional Ramps or Equivalent.
