# Access Compliance Report

## Public Rights-of-Way

### (Curb Ramps)

| Intersection ID: N/A | Main Street: TAMARACK DR | Cross Street: SINGLELEAF LN | Location: SE |

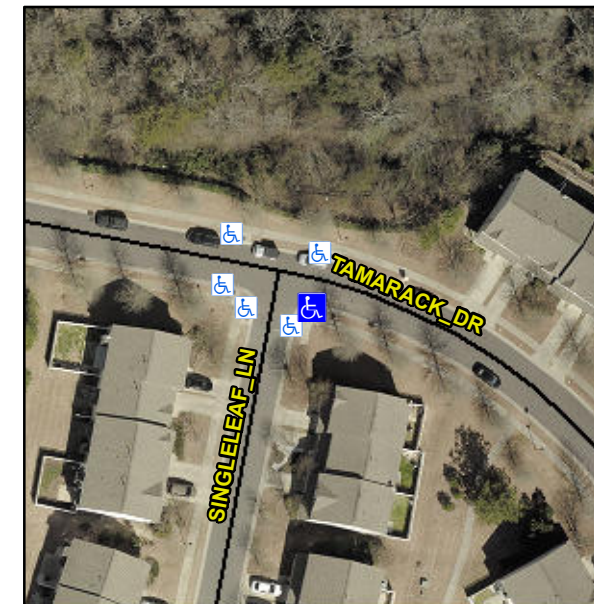
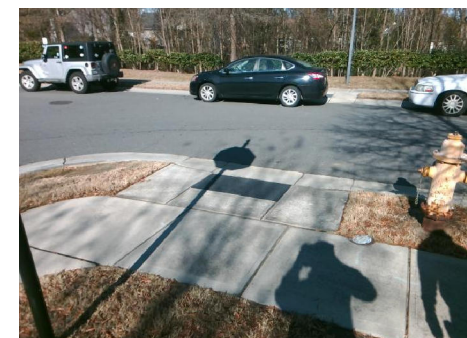
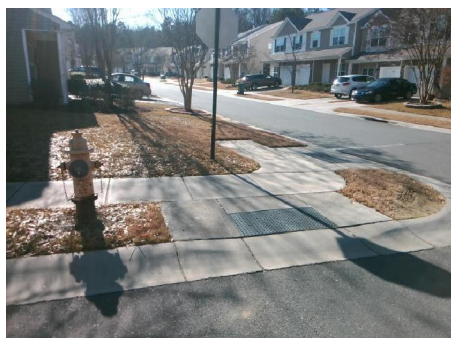
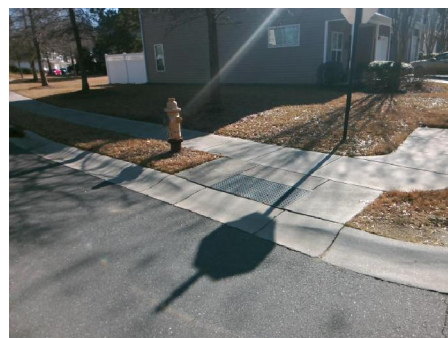
**Not Found, R304.5.3, R304.5.4**

| Compliance | Description | Data | Compliance | Description | Data |
|---|---|---|---|---|---|
| No | Landing X Slope (%) | 2.5 | Yes | DWS Full Width? | Yes |
| Yes | Gutter Ponding? | No | No | Gutter Slope (%) | 5.4 |
| | | | No | Curb Slope (%) | 9.5 |

**Remove & Replace Curb Ramp With Two New Directional Ramps or Equivalent. Remove & Replace Gutter.**
