Access Compliance Report

Public Rights-of-Way

(Curb Ramps)

Intersection ID: 6850	Main Street: BEARWALLOW_CT	Cross Street: WINGDALE_DR	Location:	E
ADA ID: 47AC27023347	Ramp Type: Perp	Initial Pass/Fail: Fail	Overall Compliance: No	Severity Score: 10

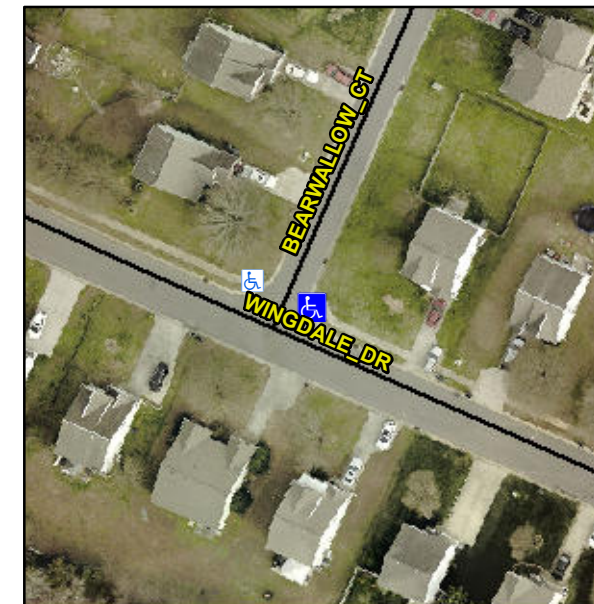
Compliance	Description	Data	Compliance	Description	Data
N/A	Ramp Length (in)	48.0	Yes	Ramp Slope (%)	5.8
No	Ramp Width (in)	39.5	No	Ramp XSlope (%)	2.1
N/A	Flare Type LT	N/A	N/A	Flare Type RT	N/A
N/A	Flare Slope LT (%)	N/A	N/A	Flare Slope RT (%)	N/A
N/A	Flare Traversable LT?	N/A	N/A	Flare Traversable RT?	N/A
N/A	Landing Length (in)	N/A	N/A	DWS Provided?	N/A
N/A	Landing Width (in)	N/A	N/A	DWS Contrast?	N/A
N/A	Landing Slope (%)	N/A	N/A	DWS Length (in)	N/A
N/A	Landing X Slope (%)	N/A	N/A	DWS Full Width?	N/A
N/A	Landing Curb? (Y/N)	N/A	N/A	DWS Offset (in)	N/A
N/A	Shared Landing?	N/A			
N/A	Gutter Ponding?	N/A	N/A	Gutter Slope (%)	N/A
N/A	Gutter Lip Ht (in)	N/A	N/A	Gutter X Slope (%)	N/A
N/A	Painted X Walk1?	No	N/A	Painted X Walk2?	N/A
	X Walk 1 Direction	To NW		X Walk 2 Direction	N/A
N/A	X Walk 1 Width (in)	N/A	N/A	X Walk 2 Width (in)	N/A
	X Walk 1 Slope (%)	0.3		X Walk 2 Slope (%)	N/A
	X Walk 1 X Slope (%)	0.4		X Walk 2 X Slope (%)	N/A

N/A	Ramp inside XWalk1?	N/A	N/A	Ramp inside XWalk2?	N/A
	Road Slope (%)	N/A	N/A	Clear Space?	N/A
	Road X Slope (%)	N/A	N/A	Clear Space to XWalk (in)	N/A
N/A	Any Obstructions?	N/A	N/A	Storm Grate/Utility Hazard?	N/A
	Obstruction Type			Storm Grate/Utility Type	
		N/A			N/A
			Yes	Surface Condition? (G/P)	Good

Possible Solutions:

Remove & Replace Entire Ramp.
