# Access Compliance Report

## Public Rights-of-Way

### (Curb Ramps)

Intersection ID: 25480	Main Street: HATTON_CROSS_DR	Cross Street: WEATHERSTONE_CR	Location: SE
ADA ID: 47B4F50B3E0E	Ramp Type: BlendTrans2	Initial Pass/Fail: Pass	Overall Compliance: No
			Severity Score: 10.25

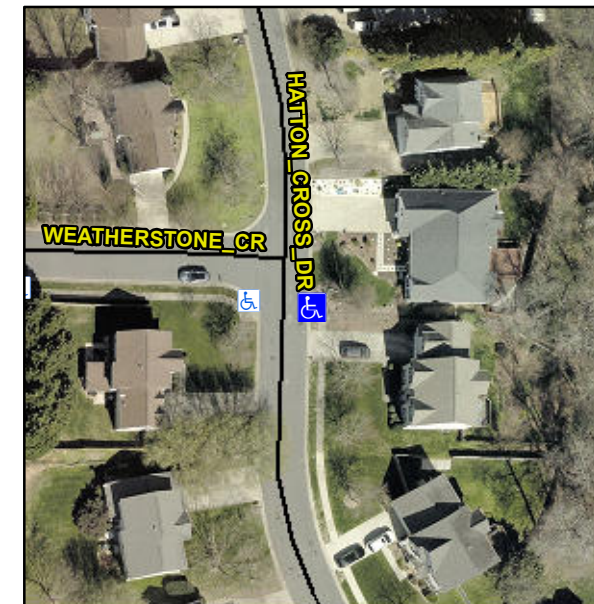
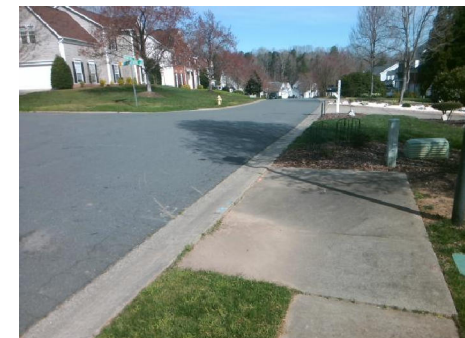
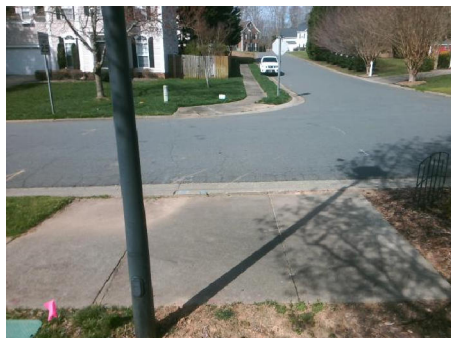
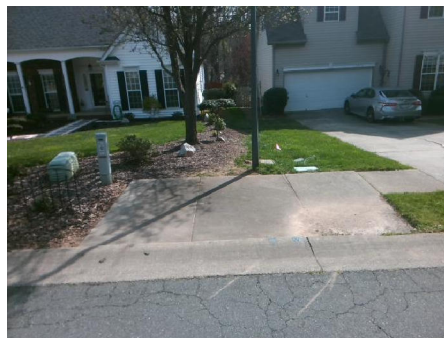
**CURB LIP 2.0**

**Not Found, R304.5.3, R305**

Compliance	Description	Data	Compliance	Description	Data
N/A	Ramp Length (in)	95.5	Yes	BlendTrans Slope (%)	1.8
Yes	Ramp Width (in)	59.5	No	BlendTrans XSlope (%)	3.6
N/A	Flare Type LT	None	N/A	Flare Type RT	None
N/A	Flare Slope LT (%)	N/A	N/A	Flare Slope RT (%)	N/A
N/A	Flare Traversable LT?	N/A	N/A	Flare Traversable RT?	N/A
N/A	Landing Length (in)	N/A	No	DWS Provided?	No
N/A	Landing Width (in)	N/A	N/A	DWS Contrast?	No
N/A	Landing Slope (%)	N/A	N/A	DWS Length (in)	N/A
N/A	Landing X Slope (%)	N/A	N/A	DWS Full Width?	No
N/A	Landing Curb? (Y/N)	No	N/A	DWS Offset (in)	N/A
N/A	Shared Landing?	No			
Yes	Gutter Ponding?	No	Yes	Gutter Slope (%)	3.0
Yes	Gutter Lip Ht (in)	0.0	Yes	Gutter X Slope (%)	2.2
N/A	Painted X Walk1?	No	N/A	Painted X Walk2?	N/A
	X Walk 1 Direction	To W		X Walk 2 Direction	N/A
	X Walk 1 Width (in)	N/A		X Walk 2 Width (in)	N/A
	X Walk 1 Slope (%)	7.6		X Walk 2 Slope (%)	N/A
	X Walk 1 X Slope (%)	3.0		X Walk 2 X Slope (%)	N/A

N/A	Ramp inside XWalk1?	N/A	N/A	Ramp inside XWalk2?	N/A
	Road Slope (%)	3.0		Clear Space?	Yes
	Road X Slope (%)	7.6	N/A	Clear Space to XWalk (in)	N/A
Yes	Any Obstructions?	No	Yes	Storm Grate/Utility Hazard?	No
	Obstruction Type			Storm Grate/Utility Type	
		N/A			N/A
			Yes	Surface Condition? (G/P)	Good
			No	Curb Slope (%)	31.5

**Remove & Replace Curb Ramp With Two New Directional Ramps or Equivalent.**
