# Access Compliance Report

## Public Rights-of-Way

### (Curb Ramps)

| Intersection ID: 14558 | Main Street: CAMERON_AV | Cross Street: GREENWAY_AV | Location: W |

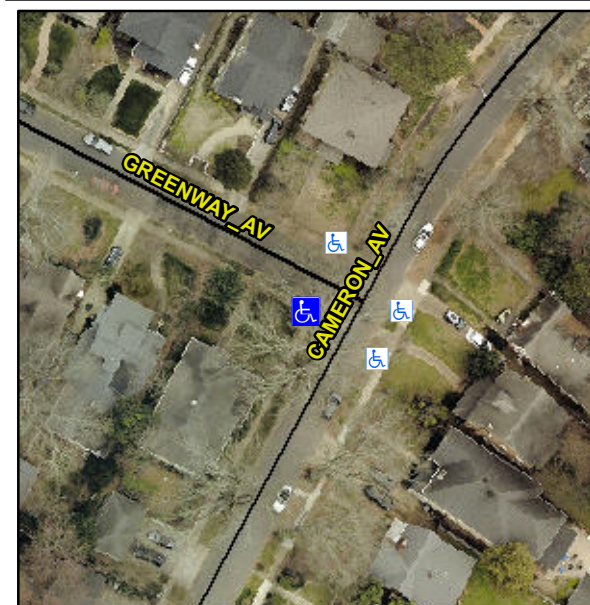
| ADA ID: 47C5E68E6F4B | Ramp Type: PerpDiag | Initial Pass/Fail: Fail | Overall Compliance: No |
| Severity Score: 12.5 | | | |

**Not Found, R304.2.2**

| Compliance | Description | Data | Compliance | Description | Data |
|---|---|---|---|---|---|
| N/A | Ramp Length (in) | 60.0 | No | Ramp Slope (%) | 11.1 |

**Remove & Replace Curb Ramp With Two New Directional Ramps or Equivalent.**

Total Cost: \$ 3200.00

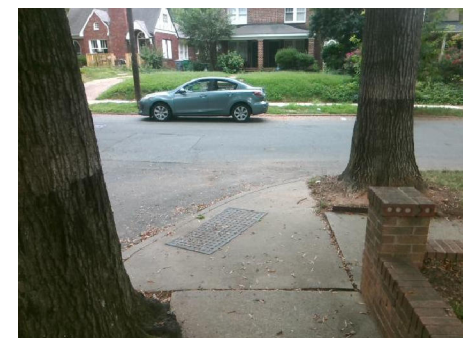
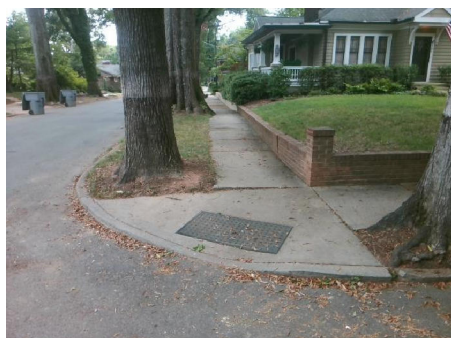
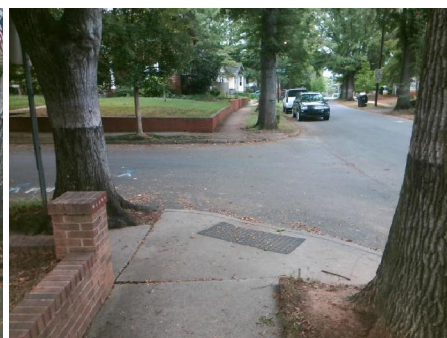
Street 1 Name CAMERON AV  
 Stop Condition-Street 2 None  
 Street 2 Name GREENWAY AV  
 Stop Condition-Street 1 StopSign
