Access Compliance Report Public Rights-of-Way (Curb Ramps)

Intersection ID: 29420 Main Street: BRADSTREET_COMMONS_WYCross Street: SALINGER_WY Location: S

ADA ID: 47C6D7E9831F Ramp Type: Perp Initial Pass/Fail: Fail Overall Compliance: No Severity Score: 25

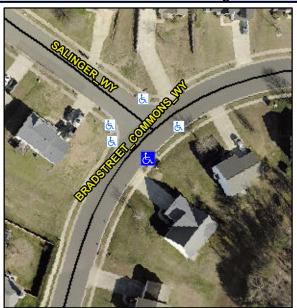
PROW/ADA:

NOT Found, R304.5.3

| Field Measurements/Component Compliance | | | | | | | |
|---|---|---|---|---|---|---|--|
| | Yes | Ramp Width (in) | 48.0 | No | Ramp XSlope (%) | 8.9 | |

Possible Solutions:

Remove & Replace Entire Ramp.

Total Cost: \$ 1850.00
