Access Compliance Report

Public Rights-of-Way

(Curb Ramps)

Intersection ID: 31905	Main Street: PALOMAR_MOUNTAIN_DR	Cross Street: STOWE_DERBY_DR	Location: SW
ADA ID: 47CA161C43BD	Ramp Type: BlendTrans2	Initial Pass/Fail: Fail	Overall Compliance: No
		Severity Score: 10

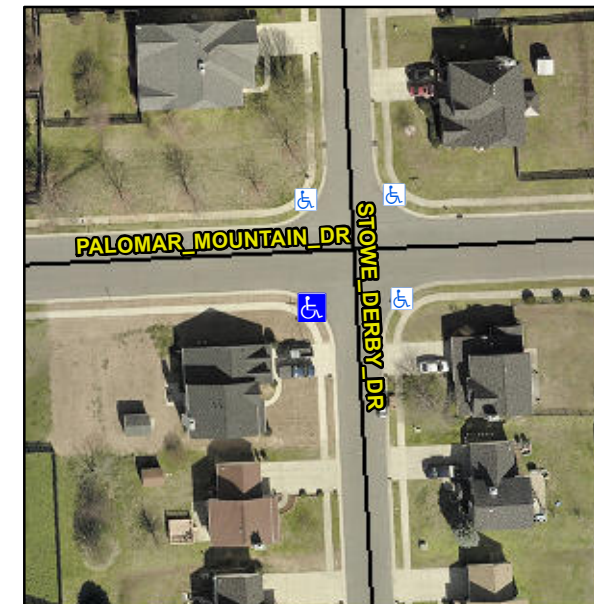
Compliance	Description	Data	Compliance	Description	Data
N/A	Ramp Length (in)	95.0	Yes	BlendTrans Slope (%)	4.7
No	Ramp Width (in)	40.0	No	BlendTrans XSlope (%)	3.3
N/A	Flare Type LT	N/A	N/A	Flare Type RT	N/A
N/A	Flare Slope LT (%)	N/A	N/A	Flare Slope RT (%)	N/A
N/A	Flare Traversable LT?	N/A	N/A	Flare Traversable RT?	N/A
N/A	Landing Length (in)	N/A	N/A	DWS Provided?	N/A
N/A	Landing Width (in)	N/A	N/A	DWS Contrast?	N/A
N/A	Landing Slope (%)	N/A	N/A	DWS Length (in)	N/A
N/A	Landing X Slope (%)	N/A	N/A	DWS Full Width?	N/A
N/A	Landing Curb? (Y/N)	N/A	N/A	DWS Offset (in)	N/A
N/A	Shared Landing?	N/A			
N/A	Gutter Ponding?	N/A	N/A	Gutter Slope (%)	N/A
N/A	Gutter Lip Ht (in)	N/A	N/A	Gutter X Slope (%)	N/A
N/A	Painted X Walk1?	No	N/A	Painted X Walk2?	No
	X Walk 1 Direction	To E		X Walk 2 Direction	To N
	X Walk 1 Width (in)	N/A		X Walk 2 Width (in)	N/A
	X Walk 1 Slope (%)	1.2		X Walk 2 Slope (%)	5.7
	X Walk 1 X Slope (%)	6.3		X Walk 2 X Slope (%)	1.0

N/A	Ramp inside XWalk1?	N/A	N/A	Ramp inside XWalk2?	N/A
	Road Slope (%)	3.4		Clear Space?	N/A
	Road X Slope (%)	5.0	N/A	Clear Space to XWalk (in)	N/A
N/A	Any Obstructions?	N/A	N/A	Storm Grate/Utility Hazard?	N/A
	Obstruction Type			Storm Grate/Utility Type	
		N/A			N/A
			Yes	Surface Condition? (G/P)	Good
			N/A	Curb Slope (%)	1.3

Remove & Replace Curb Ramp With Two New Directional Ramps or Equivalent.

R304.5.1, R304.5.3
