Access Compliance Report

Public Rights-of-Way

(Curb Ramps)

Intersection ID: 31906	Main Street: LAMOILLE_LN	Cross Street: PALOMAR_MOUNTAIN_DR	Location: NW
ADA ID: 47D172FF6F43	Ramp Type: PerpDiag	Initial Pass/Fail: Fail	Overall Compliance: No
Severity Score: 10			
Codes/Mitigation Info/Possible Solution		Field Measurements/Component Compliance

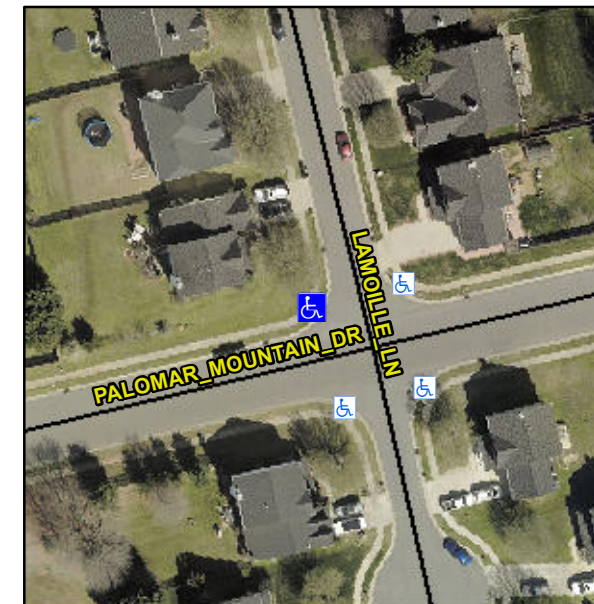
Compliance	Description	Data	Compliance	Description	Data
N/A	Ramp Length (in)	47.0	Yes	Ramp Slope (%)	5.3
No	Ramp Width (in)	43.5	No	Ramp XSlope (%)	3.9
N/A	Flare Type LT	N/A	N/A	Flare Type RT	N/A
N/A	Flare Slope LT (%)	N/A	N/A	Flare Slope RT (%)	N/A
N/A	Flare Traversable LT?	N/A	N/A	Flare Traversable RT?	N/A
N/A	Landing Length (in)	N/A	N/A	DWS Provided?	N/A
N/A	Landing Width (in)	N/A	N/A	DWS Contrast?	N/A
N/A	Landing Slope (%)	N/A	N/A	DWS Length (in)	N/A
N/A	Landing X Slope (%)	N/A	N/A	DWS Full Width?	N/A
N/A	Landing Curb? (Y/N)	N/A	N/A	DWS Offset (in)	N/A
N/A	Shared Landing?	N/A			
N/A	Gutter Ponding?	N/A	N/A	Gutter Slope (%)	N/A
N/A	Gutter Lip Ht (in)	N/A	N/A	Gutter X Slope (%)	N/A
N/A	Painted X Walk1?	No	N/A	Painted X Walk2?	No
	X Walk 1 Direction	To S		X Walk 2 Direction	To E
N/A	X Walk 1 Width (in)	N/A	N/A	X Walk 2 Width (in)	N/A
	X Walk 1 Slope (%)	1.7		X Walk 2 Slope (%)	1.0
	X Walk 1 X Slope (%)	1.9		X Walk 2 X Slope (%)	2.2

N/A	Ramp inside XWalk1?	N/A	N/A	Ramp inside XWalk2?	N/A
	Road Slope (%)	2.5	N/A	Clear Space?	N/A
	Road X Slope (%)	1.2	N/A	Clear Space to XWalk (in)	N/A
N/A	Any Obstructions?	N/A	N/A	Storm Grate/Utility Hazard?	N/A
	Obstruction Type			Storm Grate/Utility Type	
		N/A			N/A
		Yes		Surface Condition? (G/P)	Good

Possible Solutions:

Remove & Replace Curb Ramp With Two New Directional Ramps or Equivalent.

R304.5.1, R304.5.3
