## **Access Compliance Report Public Rights-of-Way** (Curb Ramps)

Intersection ID: 12170 Main Street: S POPLAR ST Cross Street: W\_4TH\_ST Location: S

**Overall Compliance: No** ADA ID: 47D2147405A9 Ramp Type: PerpDiag Initial Pass/Fail: Fail **Severity Score:** 22.5

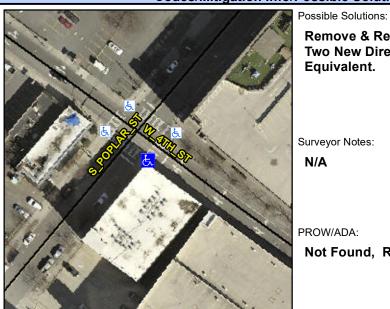
| Field Measurements/Component Compnance | | | | | | | |
|--|---|---|---|---|---|--|--|
| N/A | Ramp Length (in) | 68.0 | No | Ramp Slope (%) | 8.9 | | |
| No | Ramp Width (in) | 45.5 | Yes | Ramp XSlope (%) | 2.3 | | |

Remove & Replace Curb Ramp With **Two New Directional Ramps or Equiva**

| alent. | | | |
| DA:<br><b>ound,</b> | R304.5.1, R304.2.2 | | |

Total Cost: 3200.00
