Access Compliance Report

Public Rights-of-Way

(Curb Ramps)

Intersection ID: 15254	Main Street: IDEAL_WY	Cross Street: PARK_RD	Location: NW
ADA ID: 47D5C46C0C6F	Ramp Type: Perp	Initial Pass/Fail: Fail	Overall Compliance: No
		Severity Score: 10

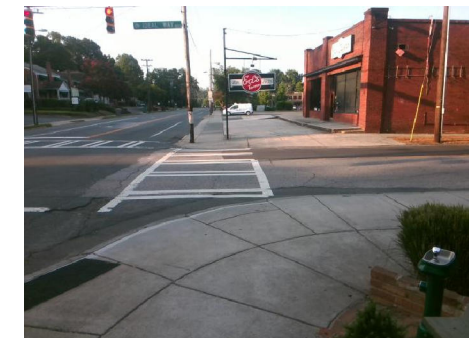
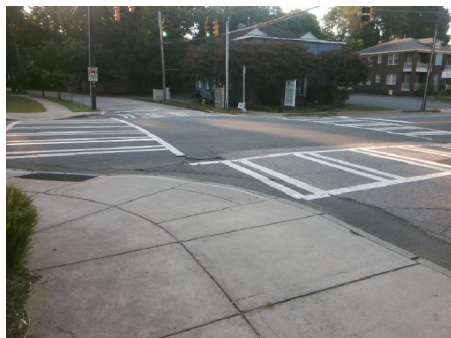
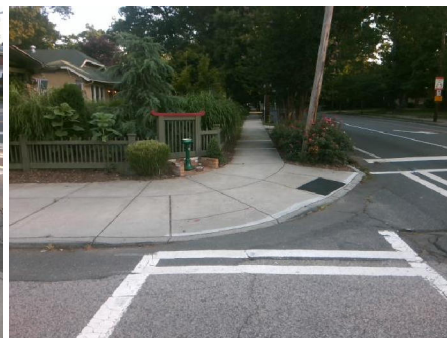
Compliance	Description	Data	Compliance	Description	Data
N/A	Ramp Length (in)	76.0	Yes	Ramp Slope (%)	5.2
No	Ramp Width (in)	36.0	No	Ramp XSlope (%)	4.4
N/A	Flare Type LT	N/A	N/A	Flare Type RT	N/A
N/A	Flare Slope LT (%)	N/A	N/A	Flare Slope RT (%)	N/A
N/A	Flare Traversable LT?	N/A	N/A	Flare Traversable RT?	N/A
N/A	Landing Length (in)	N/A	N/A	DWS Provided?	N/A
N/A	Landing Width (in)	N/A	N/A	DWS Contrast?	N/A
N/A	Landing Slope (%)	N/A	N/A	DWS Length (in)	N/A
N/A	Landing X Slope (%)	N/A	N/A	DWS Full Width?	N/A
N/A	Landing Curb? (Y/N)	N/A	N/A	DWS Offset (in)	N/A
N/A	Shared Landing?	N/A			
N/A	Gutter Ponding?	N/A	N/A	Gutter Slope (%)	N/A
N/A	Gutter Lip Ht (in)	N/A	N/A	Gutter X Slope (%)	N/A
N/A	Painted X Walk1?	Yes	N/A	Painted X Walk2?	N/A
	X Walk 1 Direction	To S		X Walk 2 Direction	N/A
N/A	X Walk 1 Width (in)	108.0	N/A	X Walk 2 Width (in)	N/A
	X Walk 1 Slope (%)	2.9		X Walk 2 Slope (%)	N/A
	X Walk 1 X Slope (%)	2.5		X Walk 2 X Slope (%)	N/A

N/A	Ramp inside XWalk1?	Yes	N/A	Ramp inside XWalk2?	N/A
	Road Slope (%)	N/A	N/A	Clear Space?	N/A
	Road X Slope (%)	N/A	N/A	Clear Space to XWalk (in)	N/A
N/A	Any Obstructions?	N/A	N/A	Storm Grate/Utility Hazard?	N/A
	Obstruction Type			Storm Grate/Utility Type	
		N/A			N/A
		Yes		Surface Condition? (G/P)	Good

Remove & Replace Entire Ramp.
