# Access Compliance Report

## Public Rights-of-Way

### (Curb Ramps)

Intersection ID: 27363	Main Street: REA_RD	Cross Street: BALLANTYNE_COMMONS_PY	Location: NE
ADA ID: 47DA3B10AFAD	Ramp Type: Perp	Initial Pass/Fail: Fail	Overall Compliance: No
Severity Score: 21.25			
Codes/Mitigation Info/Possible Solution		Field Measurements/Component Compliance

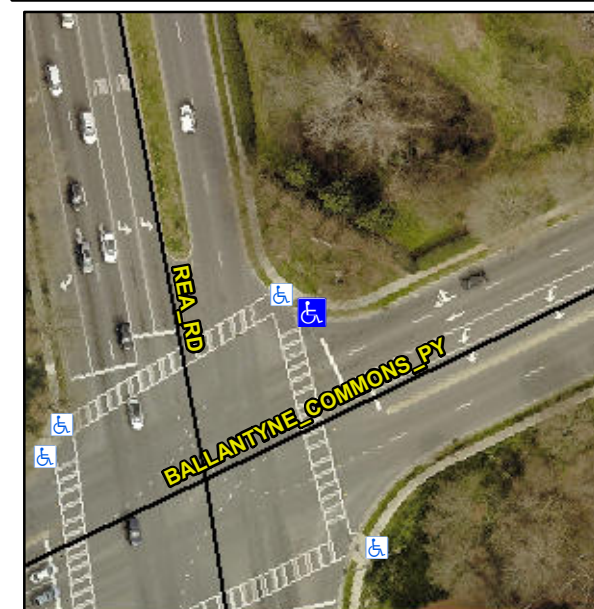
**Not Found, R304.5.1, R304.5.3**

Compliance	Description	Data	Compliance	Description	Data
N/A	Ramp Length (in)	108.0	Yes	Ramp Slope (%)	6.8
No	Ramp Width (in)	43.0	No	Ramp XSlope (%)	5.8
N/A	Flare Type LT	N/A	N/A	Flare Type RT	N/A
N/A	Flare Slope LT (%)	N/A	N/A	Flare Slope RT (%)	N/A
N/A	Flare Traversable LT?	N/A	N/A	Flare Traversable RT?	N/A
N/A	Landing Length (in)	N/A	N/A	DWS Provided?	N/A
N/A	Landing Width (in)	N/A	N/A	DWS Contrast?	N/A
N/A	Landing Slope (%)	N/A	N/A	DWS Length (in)	N/A
N/A	Landing X Slope (%)	N/A	N/A	DWS Full Width?	N/A
N/A	Landing Curb? (Y/N)	N/A	N/A	DWS Offset (in)	N/A
N/A	Shared Landing?	N/A			
N/A	Gutter Ponding?	N/A	N/A	Gutter Slope (%)	N/A
N/A	Gutter Lip Ht (in)	N/A	N/A	Gutter X Slope (%)	N/A
N/A	Painted X Walk1?	Yes	N/A	Painted X Walk2?	N/A
	X Walk 1 Direction	To S		X Walk 2 Direction	N/A
N/A	X Walk 1 Width (in)	120.0	N/A	X Walk 2 Width (in)	N/A
	X Walk 1 Slope (%)	3.8		X Walk 2 Slope (%)	N/A
	X Walk 1 X Slope (%)	0.1		X Walk 2 X Slope (%)	N/A

N/A	Ramp inside XWalk1?	No	N/A	Ramp inside XWalk2?	N/A
	Road Slope (%)	N/A	N/A	Clear Space?	N/A
	Road X Slope (%)	N/A	N/A	Clear Space to XWalk (in)	N/A
N/A	Any Obstructions?	N/A	N/A	Storm Grate/Utility Hazard?	N/A
	Obstruction Type			Storm Grate/Utility Type	
		N/A			N/A
		Yes		Surface Condition? (G/P)	Good

Possible Solutions:

**Remove & Replace Entire Ramp.  
Restripe Crosswalk.**
