Access Compliance Report Public Rights-of-Way (Curb Ramps)

Intersection ID: 10025869 Main Street: ELEVATION_POINT_DR Cross Street: N/A Location: SE **Overall Compliance: No** ADA ID: 47DA3BA150AC Ramp Type: Perp Initial Pass/Fail: Fail Severity Score: 13.75

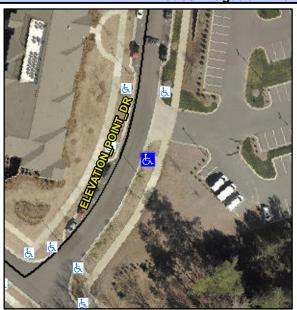
Field Measurements/Component Compliance								
Comp	liance Description	Data	Comp	liance Description	Data			
N/A	Ramp Length (in)	84.0	No	Ramp Slope (%)	9.0			
Yes	Ramp Width (in)	58.0	No	Ramp XSlope (%)	2.3			
N/A	Flare Type LT	N/A	N/A	Flare Type RT	N/A			
N/A	Flare Slope LT (%)	N/A	N/A	Flare Slope RT (%)	N/A			
N/A	Flare Traversable LT?	N/A	N/A	Flare Traversable RT?	N/A			
N/A	Landing Length (in)	N/A	N/A	DWS Provided?	N/A			
N/A	Landing Width (in)	N/A	N/A	DWS Contrast?	N/A			
N/A	Landing Slope (%)	N/A	N/A	DWS Length (in)	N/A			
N/A	Landing X Slope (%)	N/A	N/A	DWS Full Width?	N/A			
N/A	Landing Curb? (Y/N)	N/A	N/A	DWS Offset (in)	N/A			
N/A	Shared Landing?	N/A						
N/A	Gutter Ponding?	N/A	N/A	Gutter Slope (%)	N/A			
N/A	Gutter Lip Ht (in)	N/A	N/A	Gutter X Slope (%)	N/A			
N/A	Painted X Walk1?	No	N/A	Painted X Walk2?	N/A			
	X Walk 1 Direction	To W		X Walk 2 Direction	N/A			
N/A	X Walk 1 Width (in)	N/A	N/A	X Walk 2 Width (in)	N/A

X Walk 1 Slope (%)	1.1		X Walk 2 Slope (%)	N/A			
	X Walk 1 X Slope (%)	0.2		X Walk 2 X Slope (%)	N/A			
N/A	Ramp inside XWalk1?	N/A	N/A	Ramp inside XWalk2?	N/A			
	Road Slope (%)	N/A	N/A	Clear Space?	N/A			
	Road X Slope (%)	N/A	N/A	Clear Space to XWalk (in)	N/A			
N/A	Any Obstructions?	N/A	N/A	Storm Grate/Utility Hazard?	N/A			
	Obstruction Type			Storm Grate/Utility Type				
		N/A			N/A			
			Yes	Surface Condition? (G/P)	Good

Possible Solutions: Remove & Replace Entire Ramp. Surveyor Notes: N/A PROW/ADA: Not Found, R304.2.2, R304.5.3

Total Cost:	\$	1850.0
iotai oost.	Ψ	1000.0
