Access Compliance Report

Public Rights-of-Way

(Curb Ramps)

Intersection ID: 10038172	Main Street: SIR_CHARLES_PL	Cross Street: N/A	Location: NW
ADA ID: 47F2E5D81B49	Ramp Type: BlendTrans2	Initial Pass/Fail: Fail	Overall Compliance: No
		Severity Score: 10

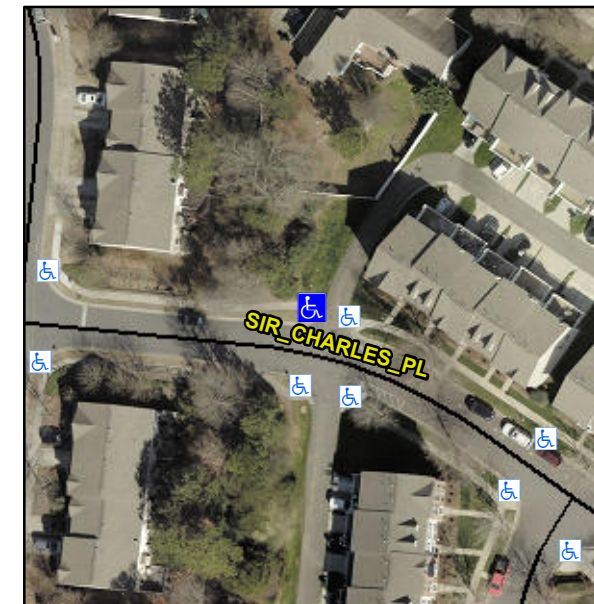
Not Found, R304.5.1, R304.5.3

Compliance	Description	Data	Compliance	Description	Data
N/A	Ramp Length (in)	102.0	Yes	BlendTrans Slope (%)	2.7
No	Ramp Width (in)	45.5	No	BlendTrans XSlope (%)	4.1
N/A	Flare Type LT	N/A	N/A	Flare Type RT	N/A
N/A	Flare Slope LT (%)	N/A	N/A	Flare Slope RT (%)	N/A
N/A	Flare Traversable LT?	N/A	N/A	Flare Traversable RT?	N/A
N/A	Landing Length (in)	N/A	N/A	DWS Provided?	N/A
N/A	Landing Width (in)	N/A	N/A	DWS Contrast?	N/A
N/A	Landing Slope (%)	N/A	N/A	DWS Length (in)	N/A
N/A	Landing X Slope (%)	N/A	N/A	DWS Full Width?	N/A
N/A	Landing Curb? (Y/N)	N/A	N/A	DWS Offset (in)	N/A
N/A	Shared Landing?	N/A			
N/A	Gutter Ponding?	N/A	N/A	Gutter Slope (%)	N/A
N/A	Gutter Lip Ht (in)	N/A	N/A	Gutter X Slope (%)	N/A
N/A	Painted X Walk1?	No	N/A	Painted X Walk2?	No
	X Walk 1 Direction	To S		X Walk 2 Direction	To E
	X Walk 1 Width (in)	N/A		X Walk 2 Width (in)	N/A
	X Walk 1 Slope (%)	1.3		X Walk 2 Slope (%)	1.5
	X Walk 1 X Slope (%)	2.7		X Walk 2 X Slope (%)	3.3

N/A	Ramp inside XWalk1?	N/A	N/A	Ramp inside XWalk2?	N/A
	Road Slope (%)	3.8		Clear Space?	N/A
	Road X Slope (%)	4.1	N/A	Clear Space to XWalk (in)	N/A
N/A	Any Obstructions?	N/A	N/A	Storm Grate/Utility Hazard?	N/A
	Obstruction Type			Storm Grate/Utility Type	
		N/A			N/A
			Yes	Surface Condition? (G/P)	Good
			No	Curb Slope (%)	10.6

Remove & Replace Curb Ramp With Two New Directional Ramps or Equivalent.
