# Access Compliance Report

## Public Rights-of-Way

### (Curb Ramps)

| Intersection ID: 6218 | Main Street: BEAM_LAKE_DR | Cross Street: PEACHWOOD_DR | Location: NW |

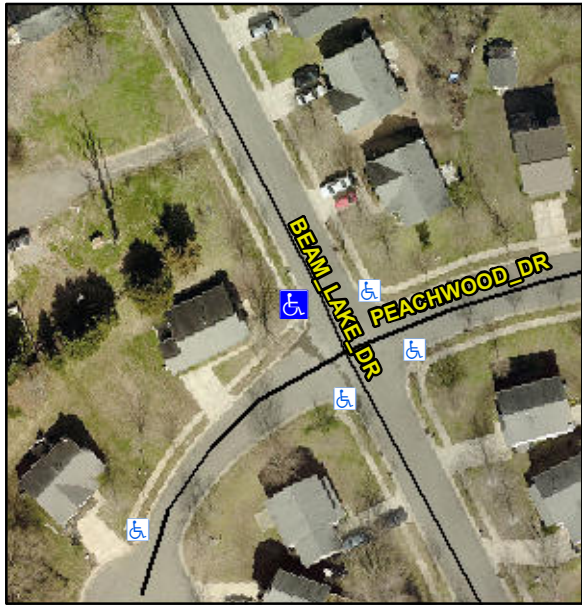
| ADA ID: 480738CCBB37 | Ramp Type: PerpDiag | Initial Pass/Fail: Fail | Overall Compliance: No |
| Severity Score: 31.25 | | | |

| | Not Found, R304.5.1, R304.2.2, R304.5.3 | | | |

| Compliance | Description | Data | Compliance | Description | Data |
|---|---|---|---|---|---|
| N/A | Ramp Length (in) | 47.0 | No | Ramp Slope (%) | 10.0 |
| No | Ramp Width (in) | 32.0 | No | Ramp XSlope (%) | 2.6 |

| | Remove & Replace Curb Ramp With Two New Directional Ramps or Equivalent. | | | |
| | Total Cost: | | \$ | 3200.00 |
